**Boat Scarring Effects on
Submerged Aquatic Vegetation in Virginia
(Year 1)**

Final Report to the Virginia Saltwater Recreational Fishing Development Fund
Virginia Marine Resources Commission
Newport News, Virginia

October, 2001

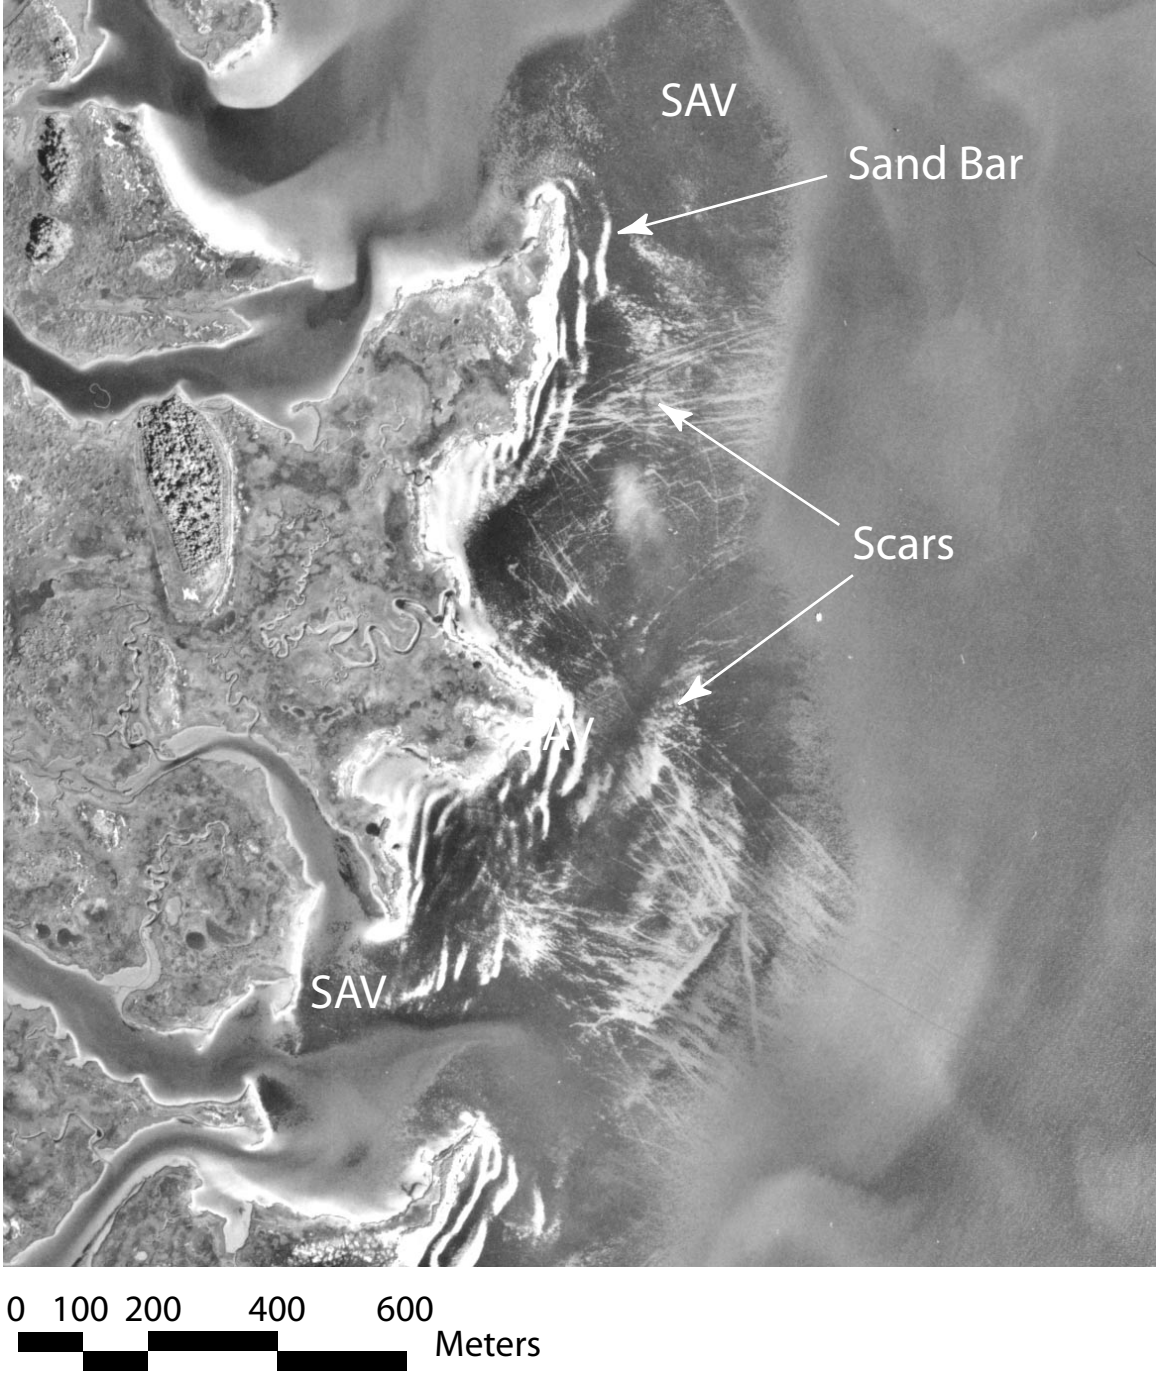
Figure 1: Brown's Bay, 1992

Scars were identified as thin white or dark lines running through the darker background of the grass bed (**Figure 1**). Previous field examinations have confirmed that such photographic signatures are in fact propeller scars and are often as narrow as 0.5 m (approximately 2 feet).

Figure 1) 1:24,000 scale aerial photograph of Brown's Bay, 1992. SAV are the darker areas of the photographs. Arrows point to sand bars and propeller scars.

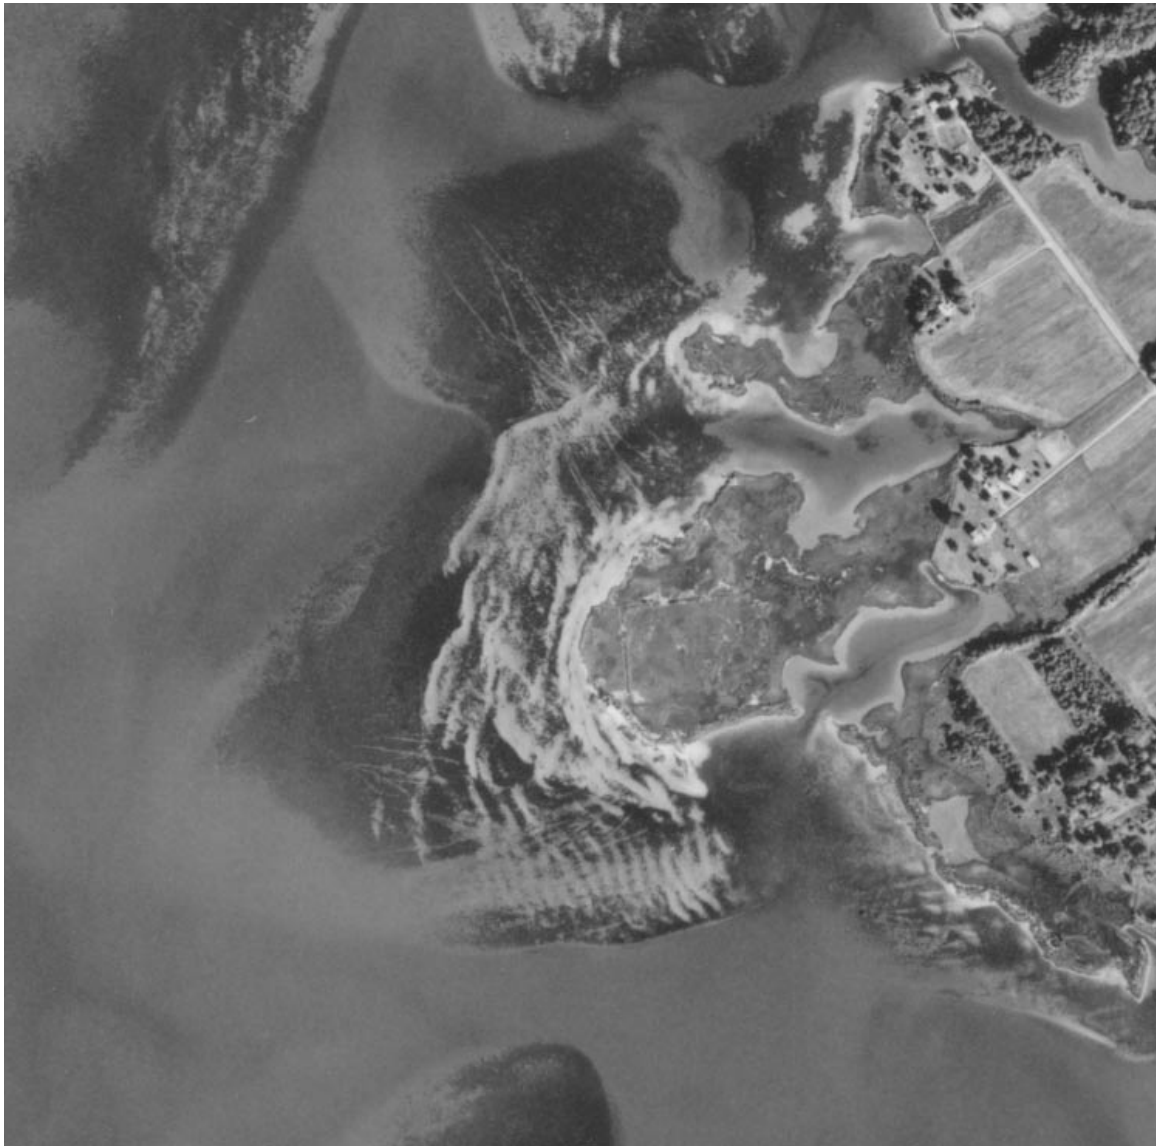
Figure 10: Pepper Creek, 1992

- Pepper Creek (**Figure 10**): 11 years with primarily light intensity scarring.
- Minter Point (**Figure 11**): 12 years with light and moderate intensity scarring.
- Ware Neck Point (**Figure 12**): 12 years with light and moderate intensity scarring.
- Bush Point (**Figure 13**): 12 years with primarily light intensity scarring.
- Guinea Marsh (**Figure 14**): 12 years with light and moderate intensity scarring.
- Goodwin Island- Northern Shore (**Figure 15**): 12 years with light and moderate intensity scarring.
- Brown's Bay (**Figure 1**): 13 years with light and moderate intensity scarring
- Allen's Island (**Figure 16**): 13 years with light and moderate intensity scarring.
- Plum Tree Island (**Figure 17**): 13 years. This site also had scars oriented randomly relative to the shoreline.

Figure 10) 1:24,000 scale aerial photograph of Pepper Creek in 1992.

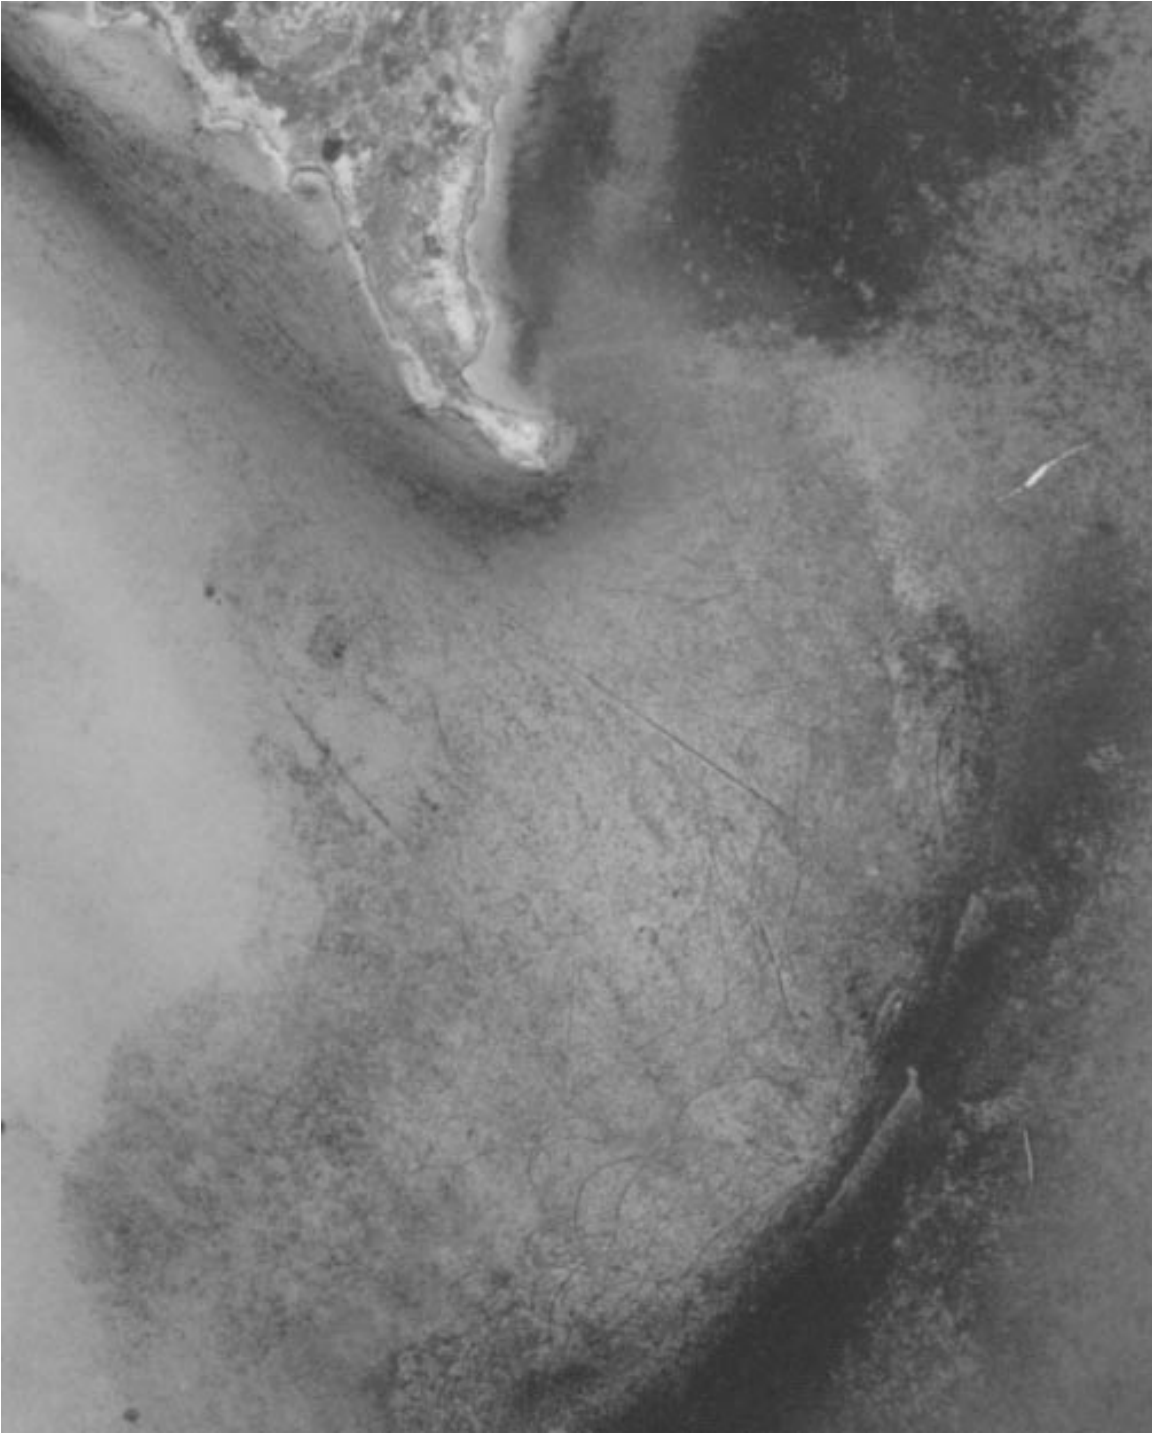
Figure 18: South Point Marsh, 1990

- South Point Marsh (**Figure 18**): 10 years with light and moderate scarring.
- Near Goose Island (**Figure 19**): 11 years with light and moderate intensity scarring. Severe scarring was visible in 1990 and 1998.

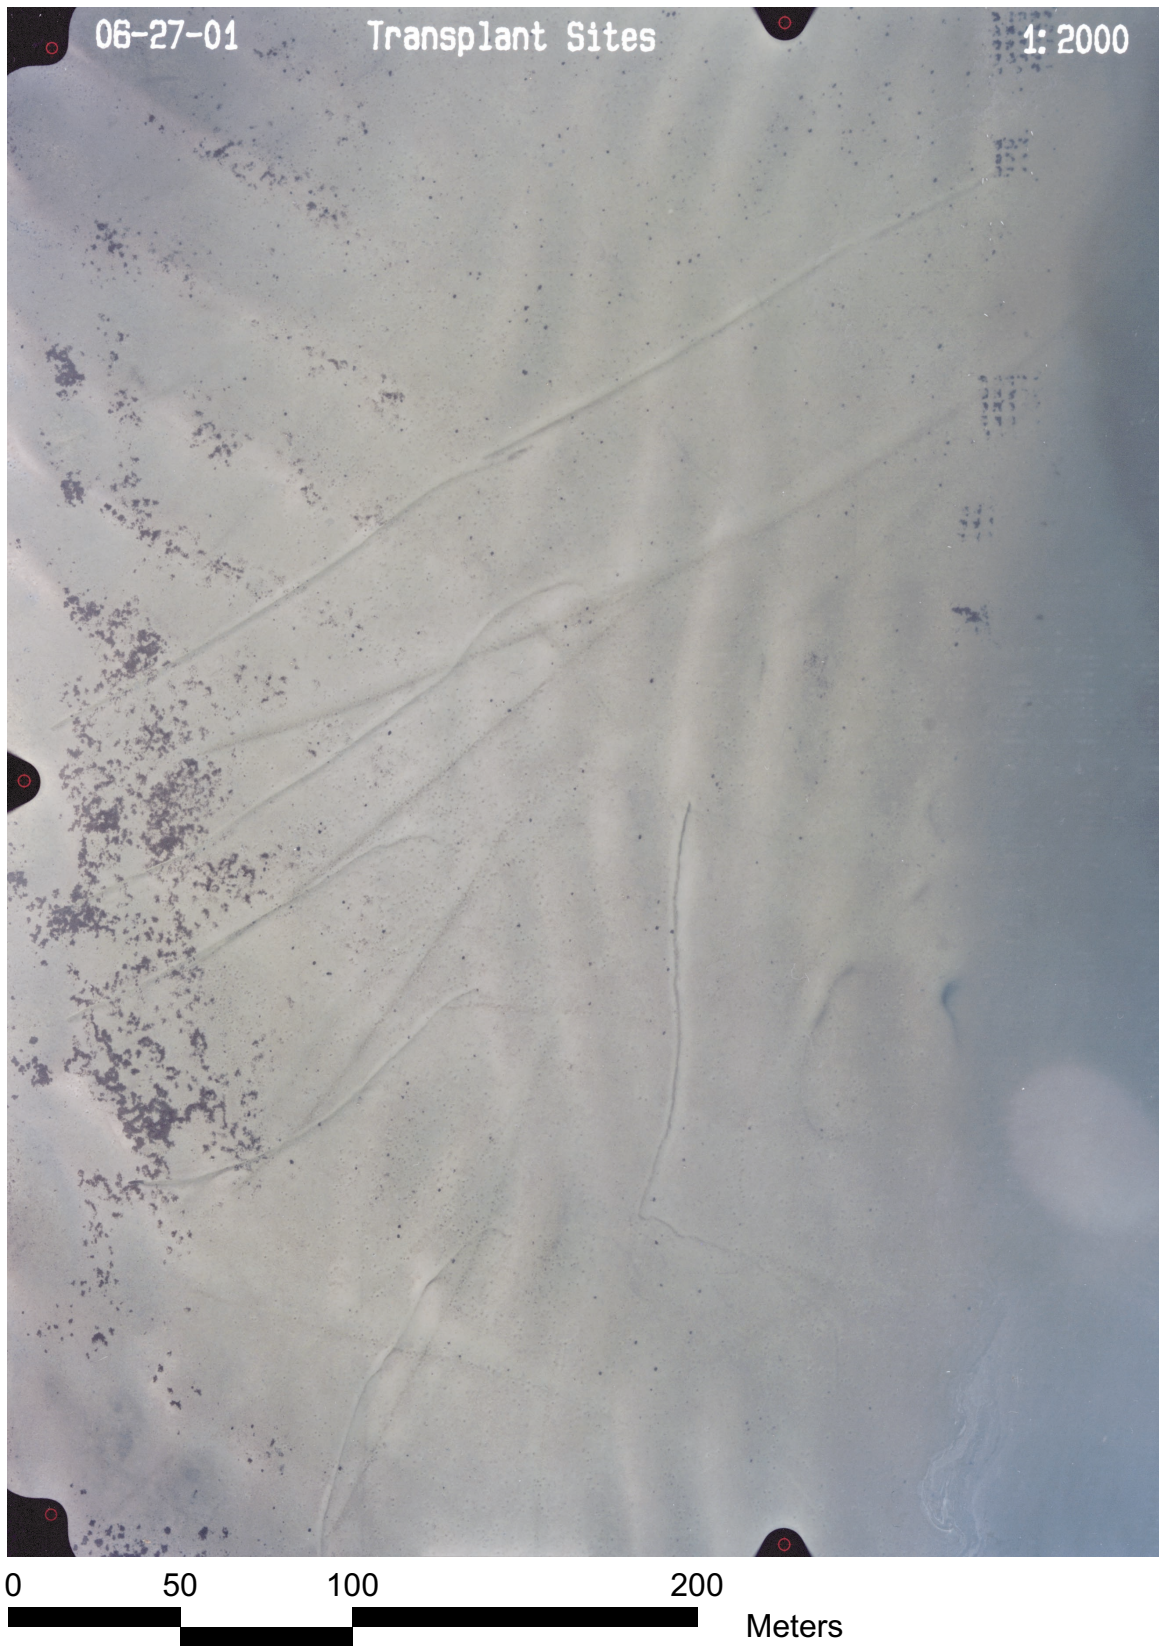
Figure 23: Haul Seine Scars on Southern Shore of York River, 2001

Figure 23) 1:2,000 scale aerial photograph of an area west of Wormley Creek in the York River taken in 2001 showing propeller scars running through unvegetated areas. Eelgrass restoration transplants are visible at the edge of the shoal. This area has been repeatedly observed to be haul seined.

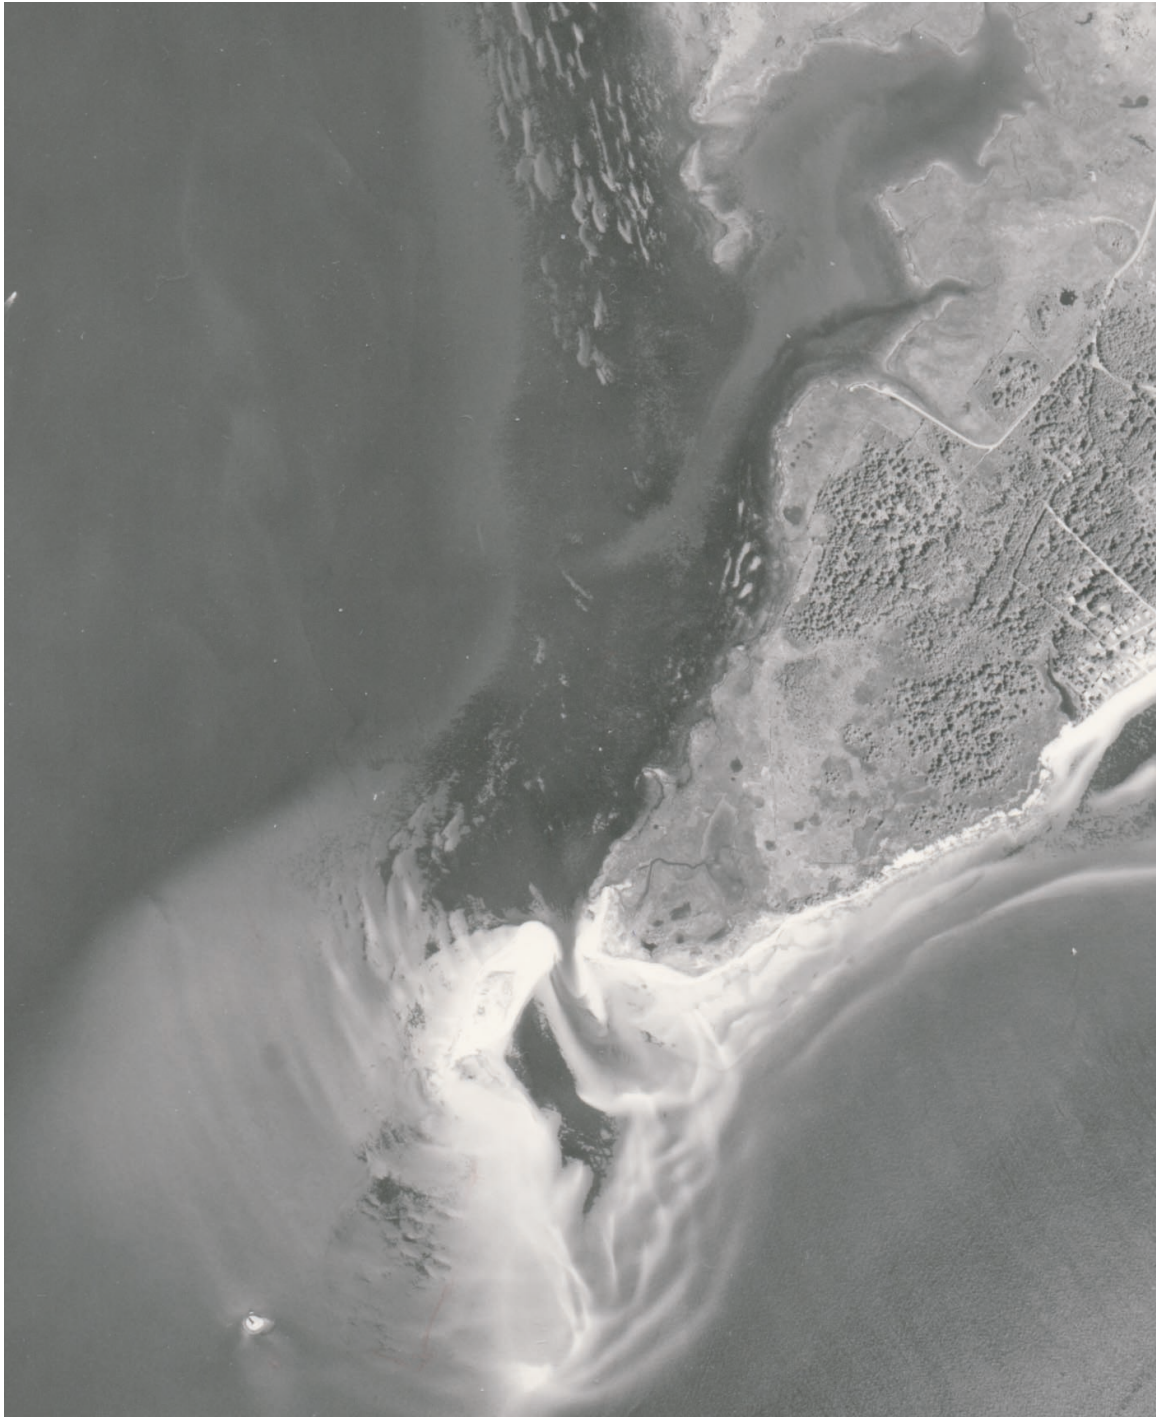
Figure 25: New Point Comfort, 1998

Figure 25) 1:24000 scale aerial photograph of New Point Comfort in 1998.
