**REPORT TO THE VIRGINIA MARINE RESOURCES COMMISSION:**

**Evidence of Widespread Destruction of  
Submersed Aquatic Vegetation (SAV)  
from Clam Dredging in Chincoteague Bay, Virginia**

**Dr. Kenneth A. Moore and Dr. Robert J. Orth**

**October 28, 1997**

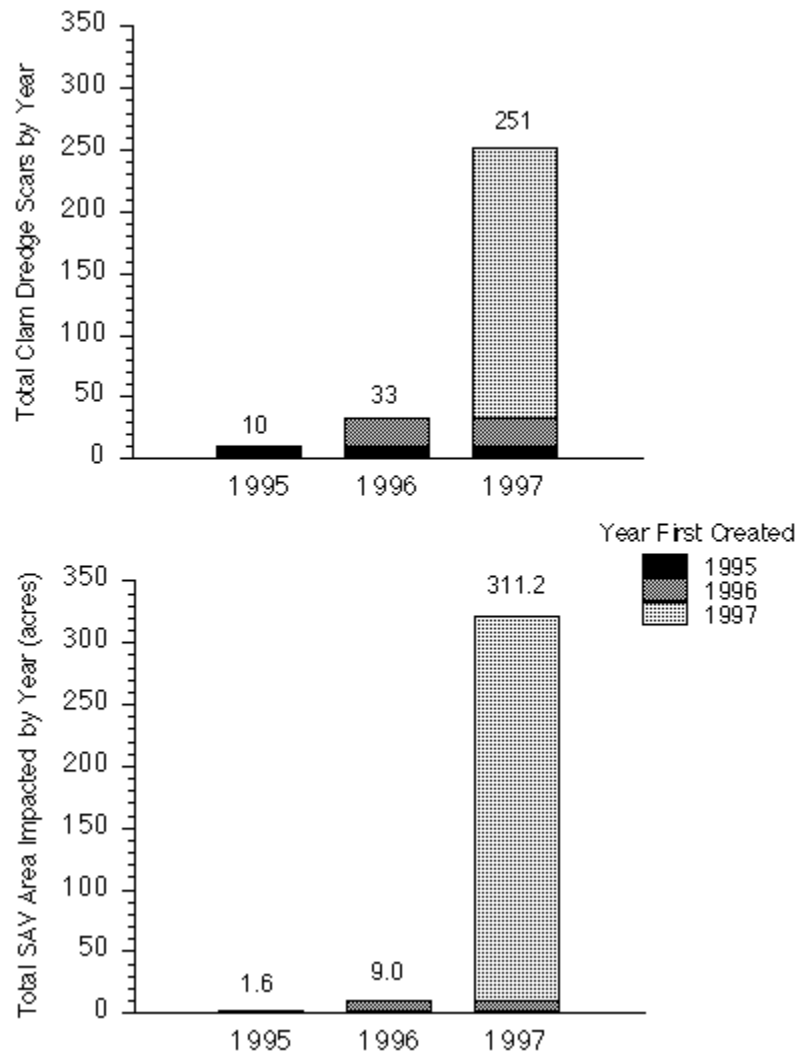
**Figure 2.** Chincoteague Bay, Virginia Clam Dredging Scars in SAV Beds

No circular dredging scars were observed in SAV aerial photography prior to 1995. In photography taken in May of 1995 a total of 10 circular clam dredge scars averaging approximately 29 m (95 ft) in diameter were counted. These impacted approximately 1.6

acres of SAV vegetation resulting in apparent loss of nearly all vegetation within the dredged circles (Fig. 2).

In photography taken in July of 1996 an additional 23 circular dredged areas within SAV beds were evident. These were somewhat larger, averaging approximately 44 m (145 ft) in diameter. The 1995 dredged areas demonstrated little change in appearance and all were evident in 1996. Newly dredged SAV bottom in 1996 was estimated to be approximately 7.4 acres (Fig. 2).

Aerial photography taken in May 1997 reveals an additional, approximate 208 dredged areas within SAV beds. These dredged areas range in size from 36 m (119 ft) to 84 m (277 ft) at different sites. Many are as large as 120 m (396 ft) in diameter. Because some large areas have been overlapped with many circular dredged sets, the precise number of circles is difficult to determine. The number of dredged circles estimated is a conservative count, the actual number of new sets of gear in SAV beds in 1997 may be as high as 300. All circular dredged areas first observed in 1995 and 1996 are still evident, with little change in 1997. Total additional area of SAV dredged in 1997 was approximately 302 acres (Fig. 2). These data indicate that as of 1997 approximately 6.3% of the 4912 acres of SAV (1996 data) mapped in the Virginia portion of Chincoteague Bay was impacted by the circular clam dredging, with most of the dredging occurring in 1997.

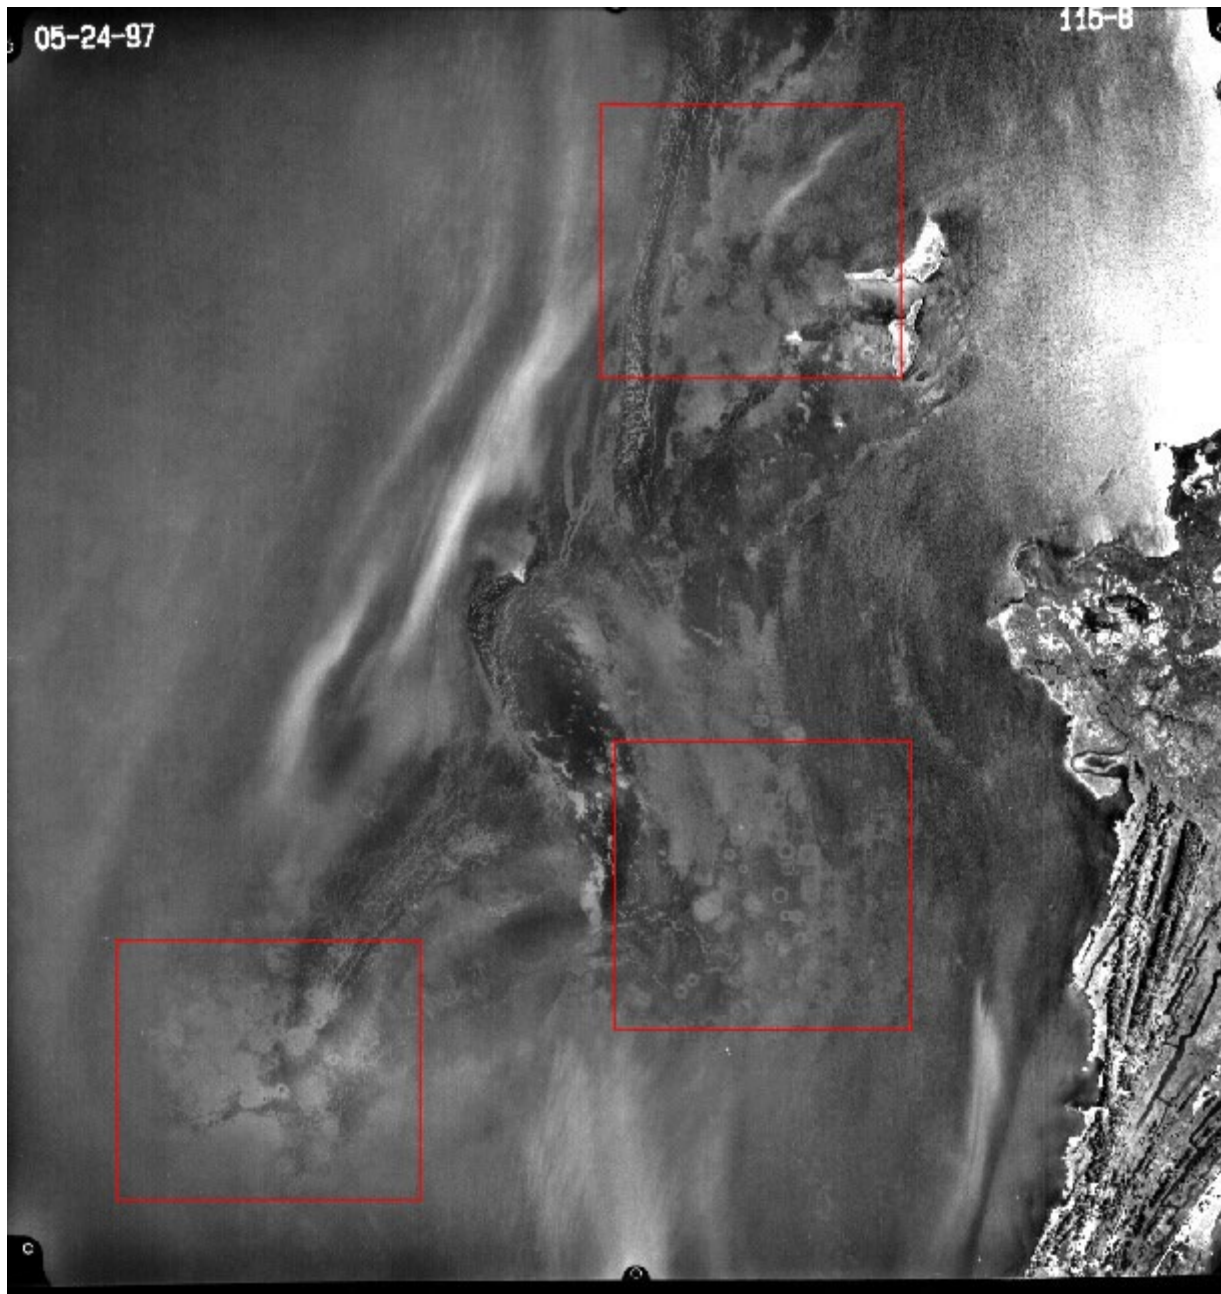
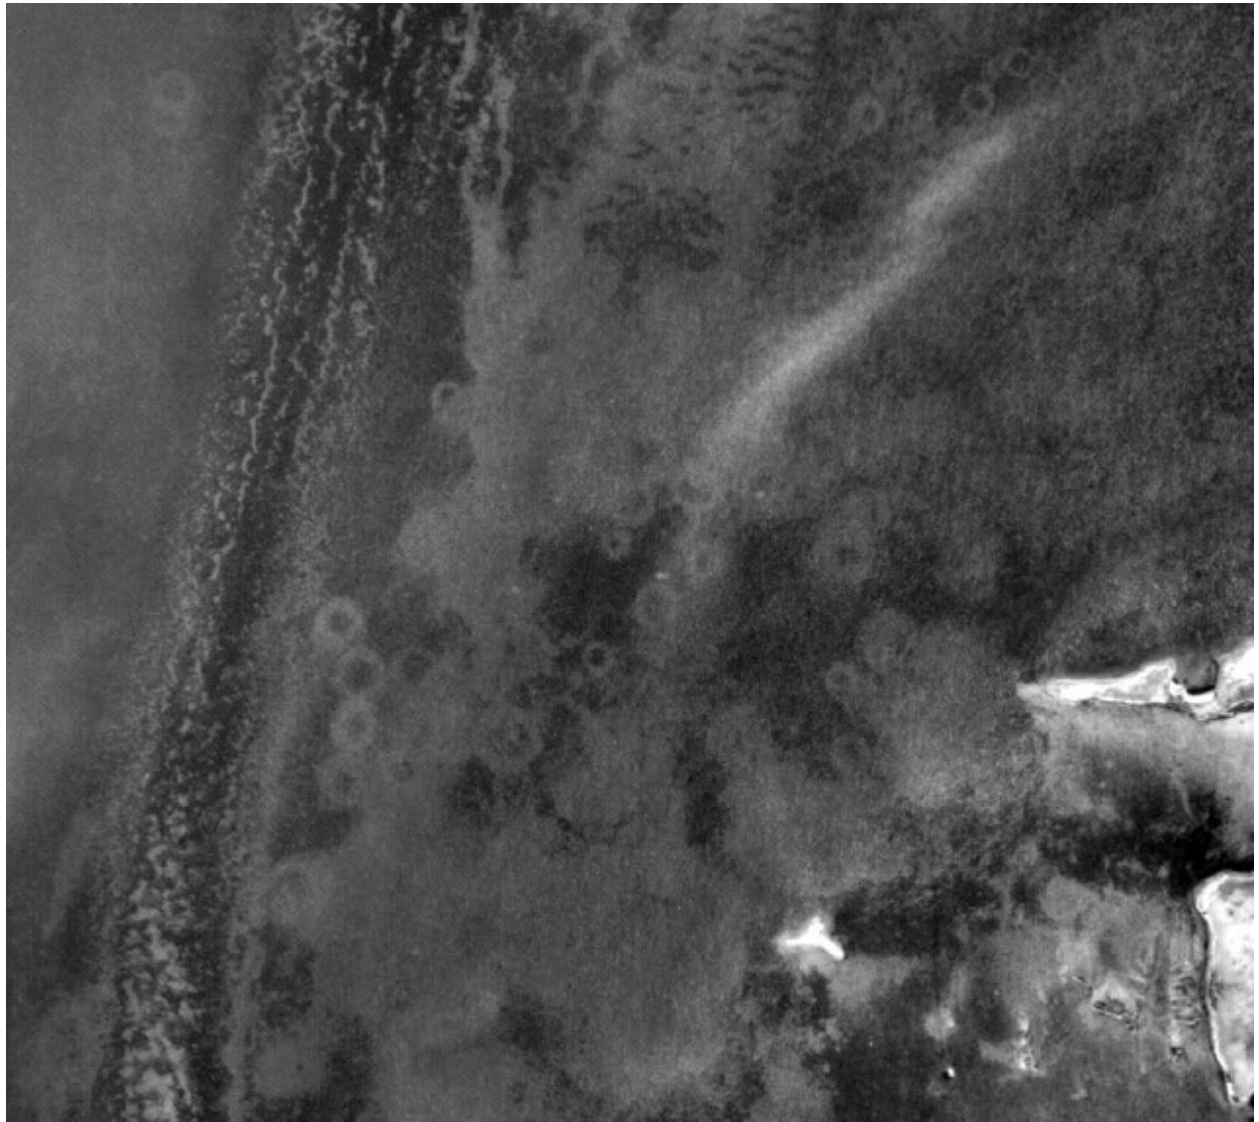
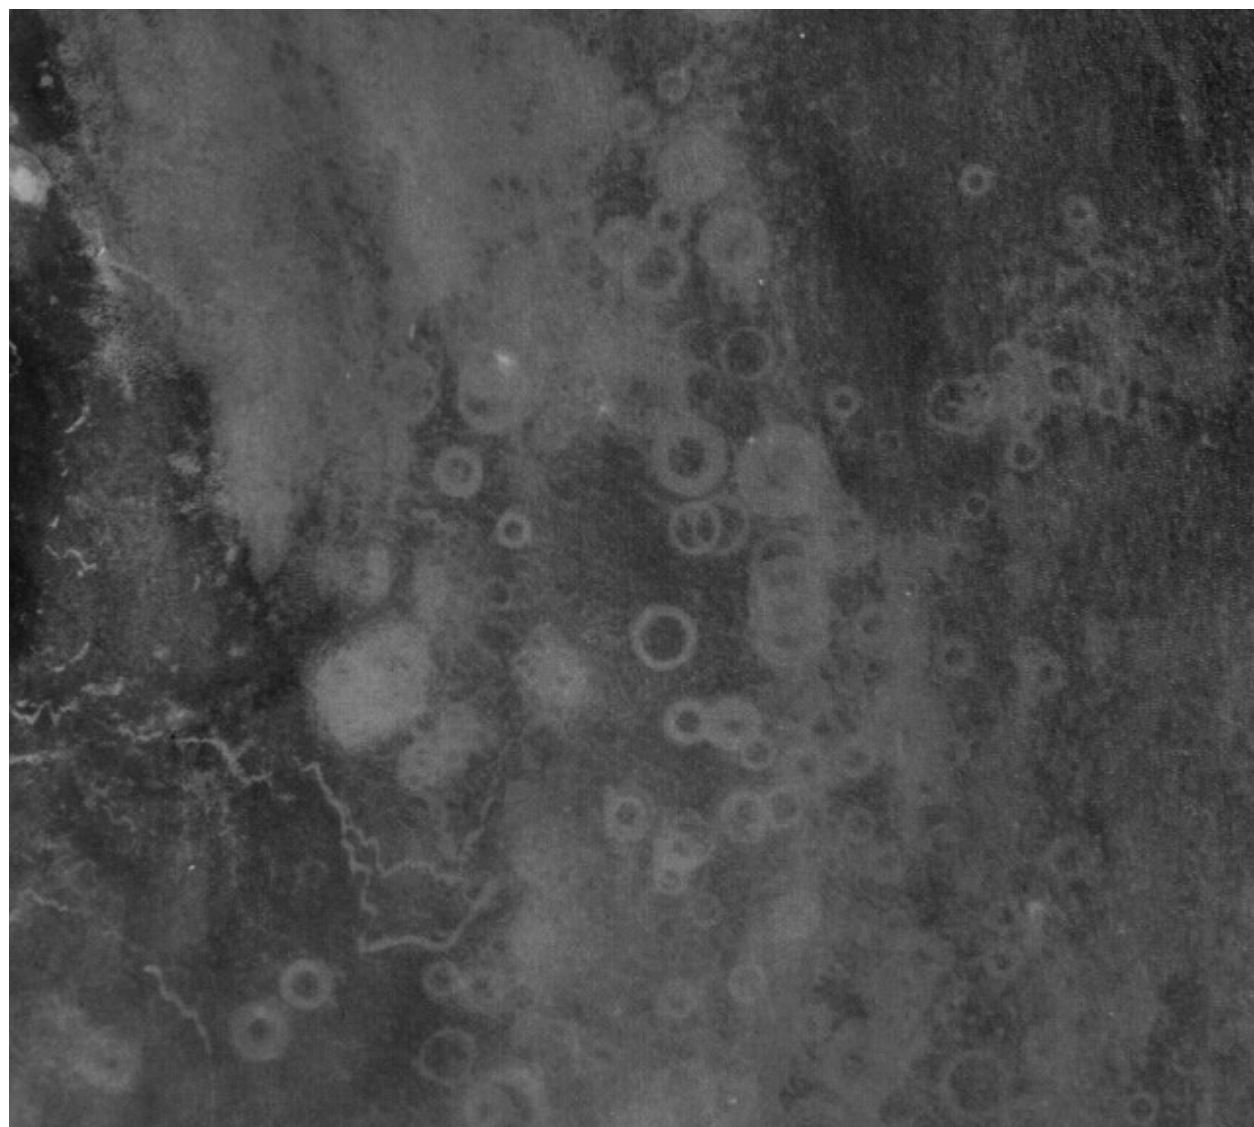
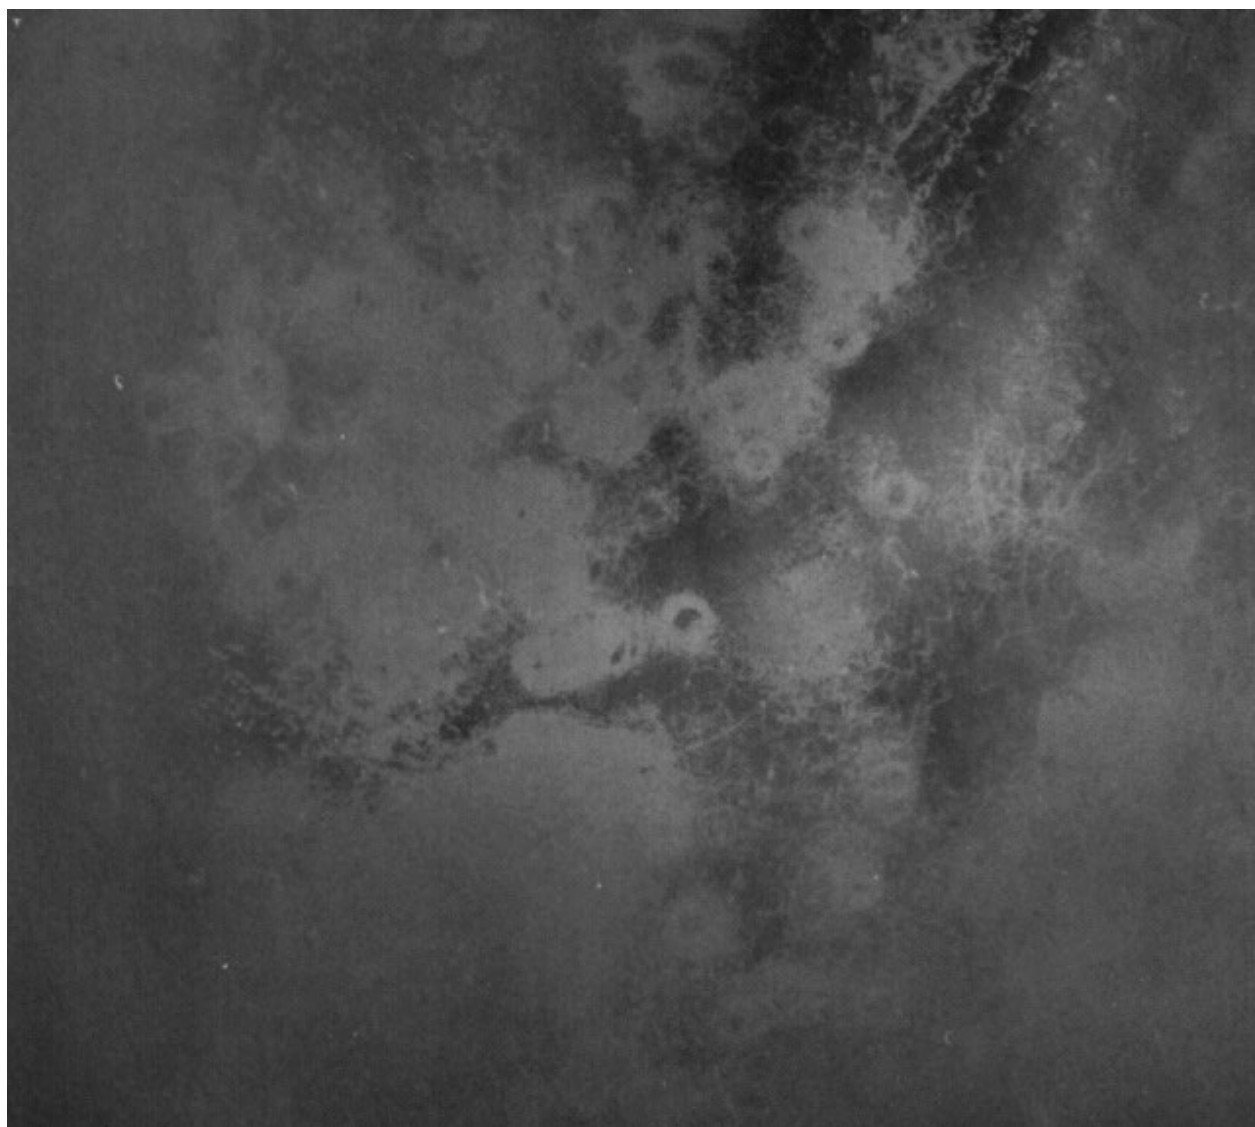
**SAV Photo 115-8, taken 5/24/97**

**1:24,000 Scale Aerial Photography Documenting Circular Dredge Scars**
