**Letter report to Maryland Department of Natural Resources Secretary Griffin,  
concerning dredge scars in Maryland coastal bay SAV beds:**

**1:24,000 Scale Aerial Photography Documenting Dredge Scars in the Maryland Coastal Bays**

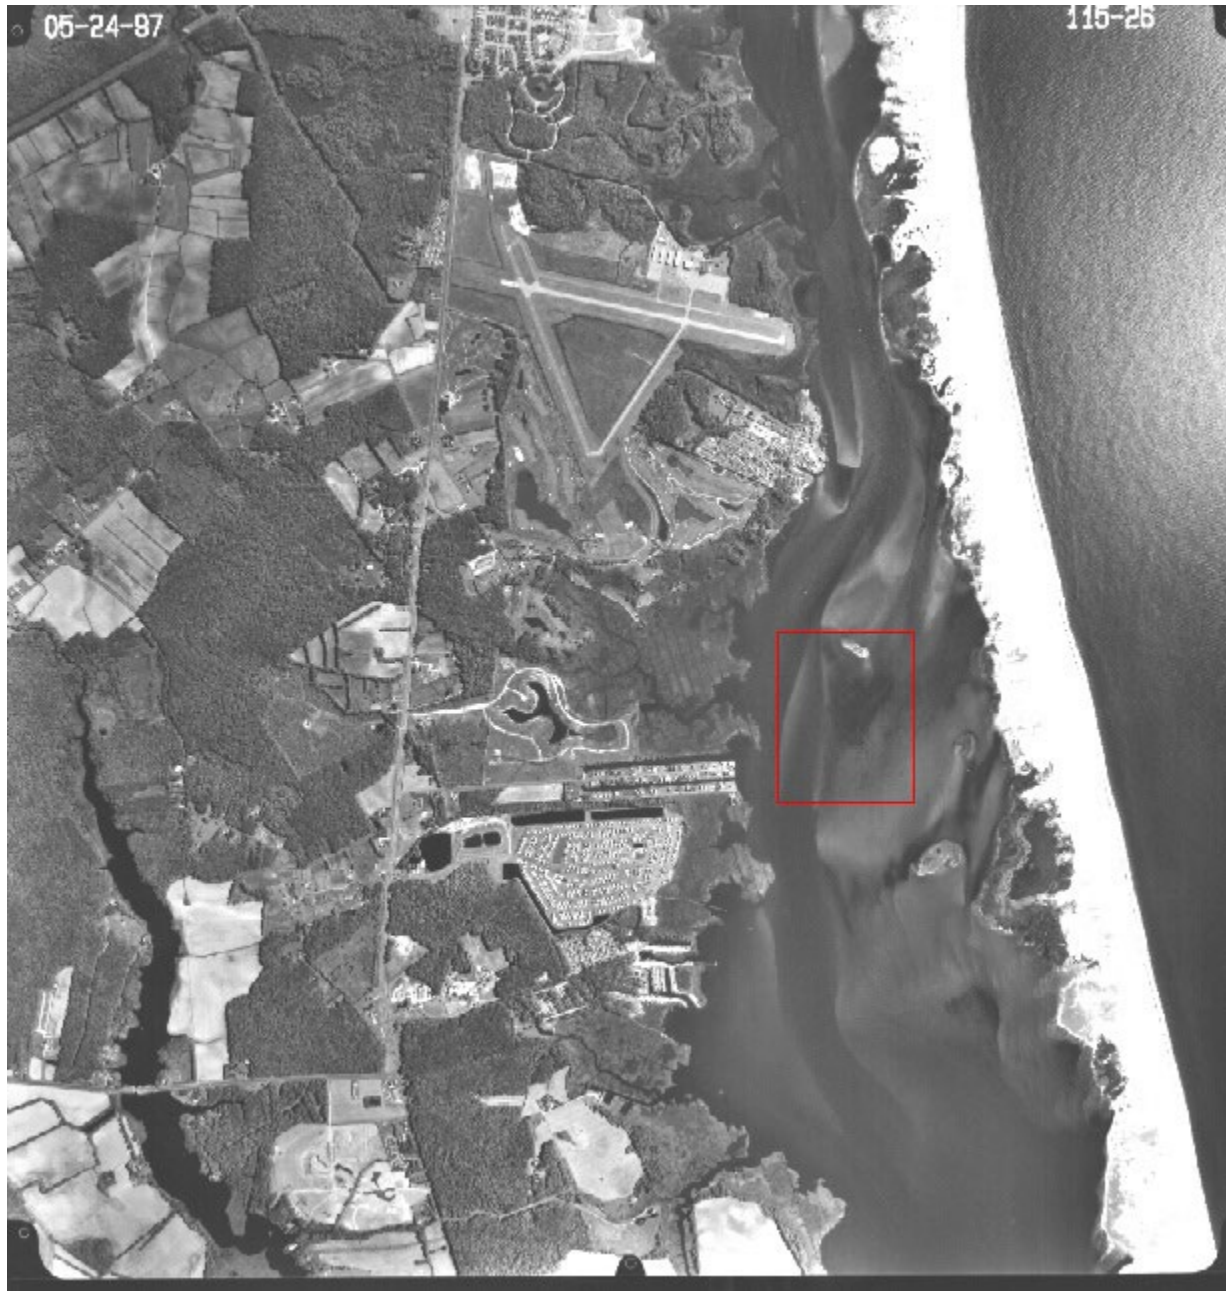
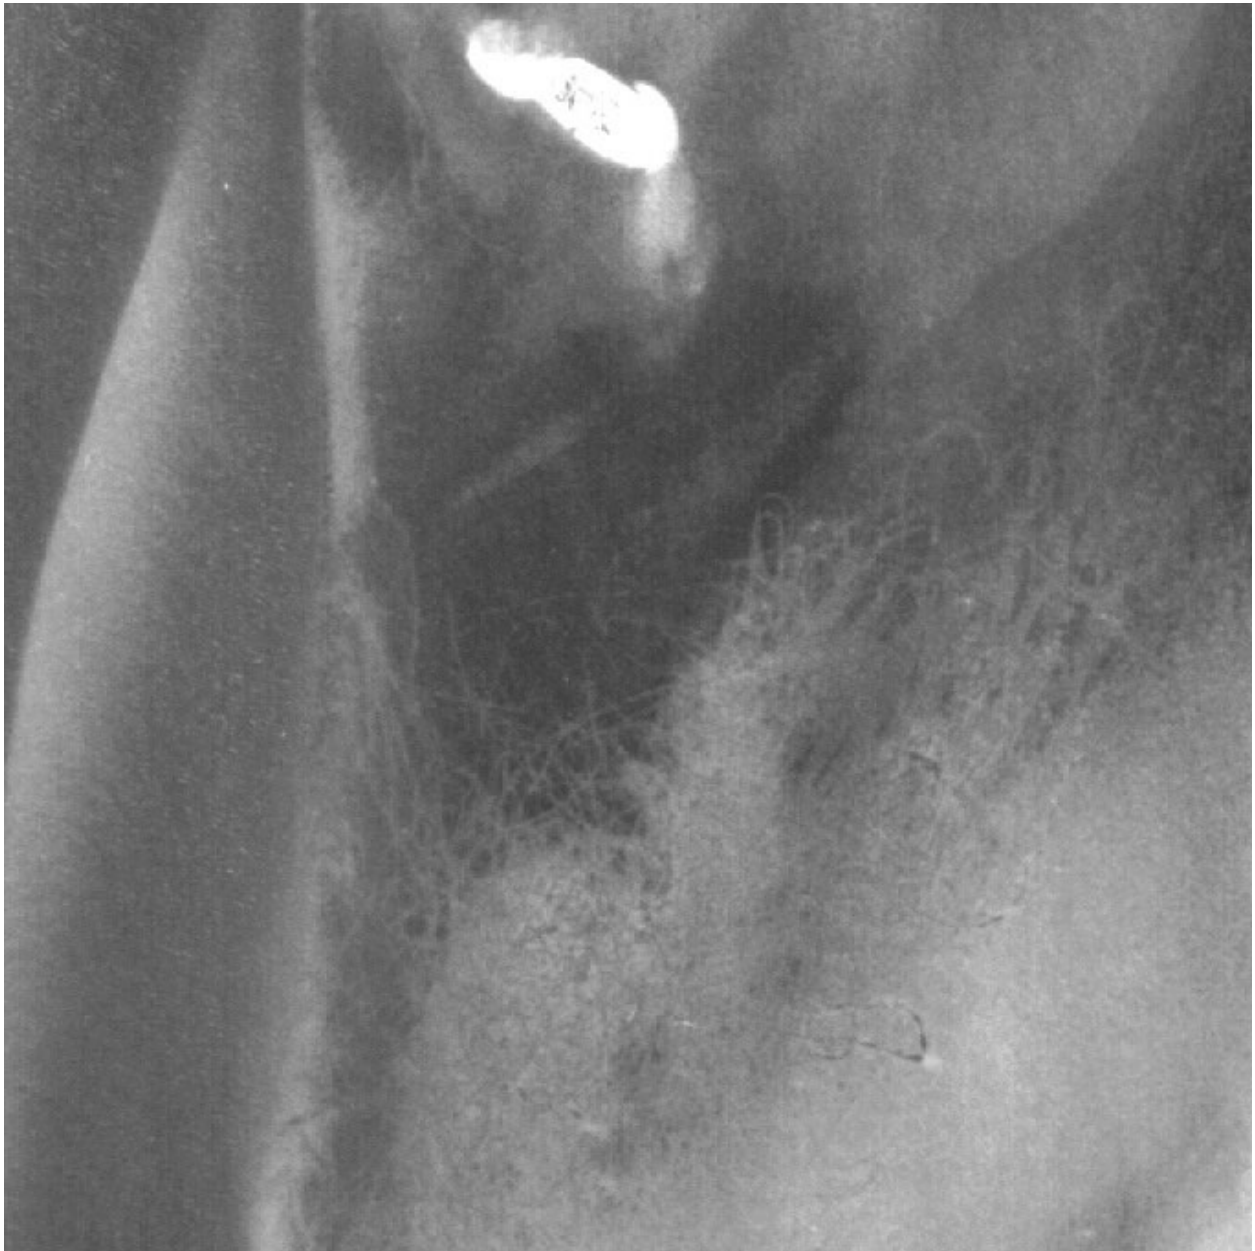
**SAV Photo 115-26, taken 5/24/97**

Our intent here is to report unprecedented damage to SAV beds in Maryland's coastal bays which we believe is attributable to activities of commercial clam harvesting by hydraulic escalators. Damage which is documented in aerial photographs ([see accompanying photographs](#)) obtained annually for mapping SAV is of such a significant nature that we believe it may impact the long term recovery of SAV in Chincoteague and Sinepuxent bays. SAV's are at their highest levels of abundance since 1933 when they were completely eliminated in the coastal bays by a combination of disease and a 1933 hurricane. Recovery of SAV was initially slow but has been rapidly spreading during the period of the annual survey which started in the coastal bays in 1986.

3. The widths of the scars are approximately 3 to 4.5 ft. This is similar to that of a hydraulic dredge head. Recreational boats will generally not create a scar of this width.

4. The length of the scars are hundreds of yards long and run along bed edges as well as across entire beds. We would not expect recreational boaters to continue with their motors in a down position for such long distances. In addition, there are literally hundreds of scars in some areas.

We believe this photographic record is graphic evidence that one type of commercial dredging activity is very detrimental to SAV beds in the coastal bays and the impacts are rapidly increasing. We urge you to take immediate action to prevent further damage to SAV beds in this region. Lack of action now will most likely lead to further damage to the existing SAV beds. We would be happy to work with your staff in whatever capacity necessary to insure adequate protection.
