**Boat Scarring Effects on
Submerged Aquatic Vegetation in Virginia
(Year 1)**

Final Report to the Virginia Saltwater Recreational Fishing Development Fund
Virginia Marine Resources Commission
Newport News, Virginia

October, 2001

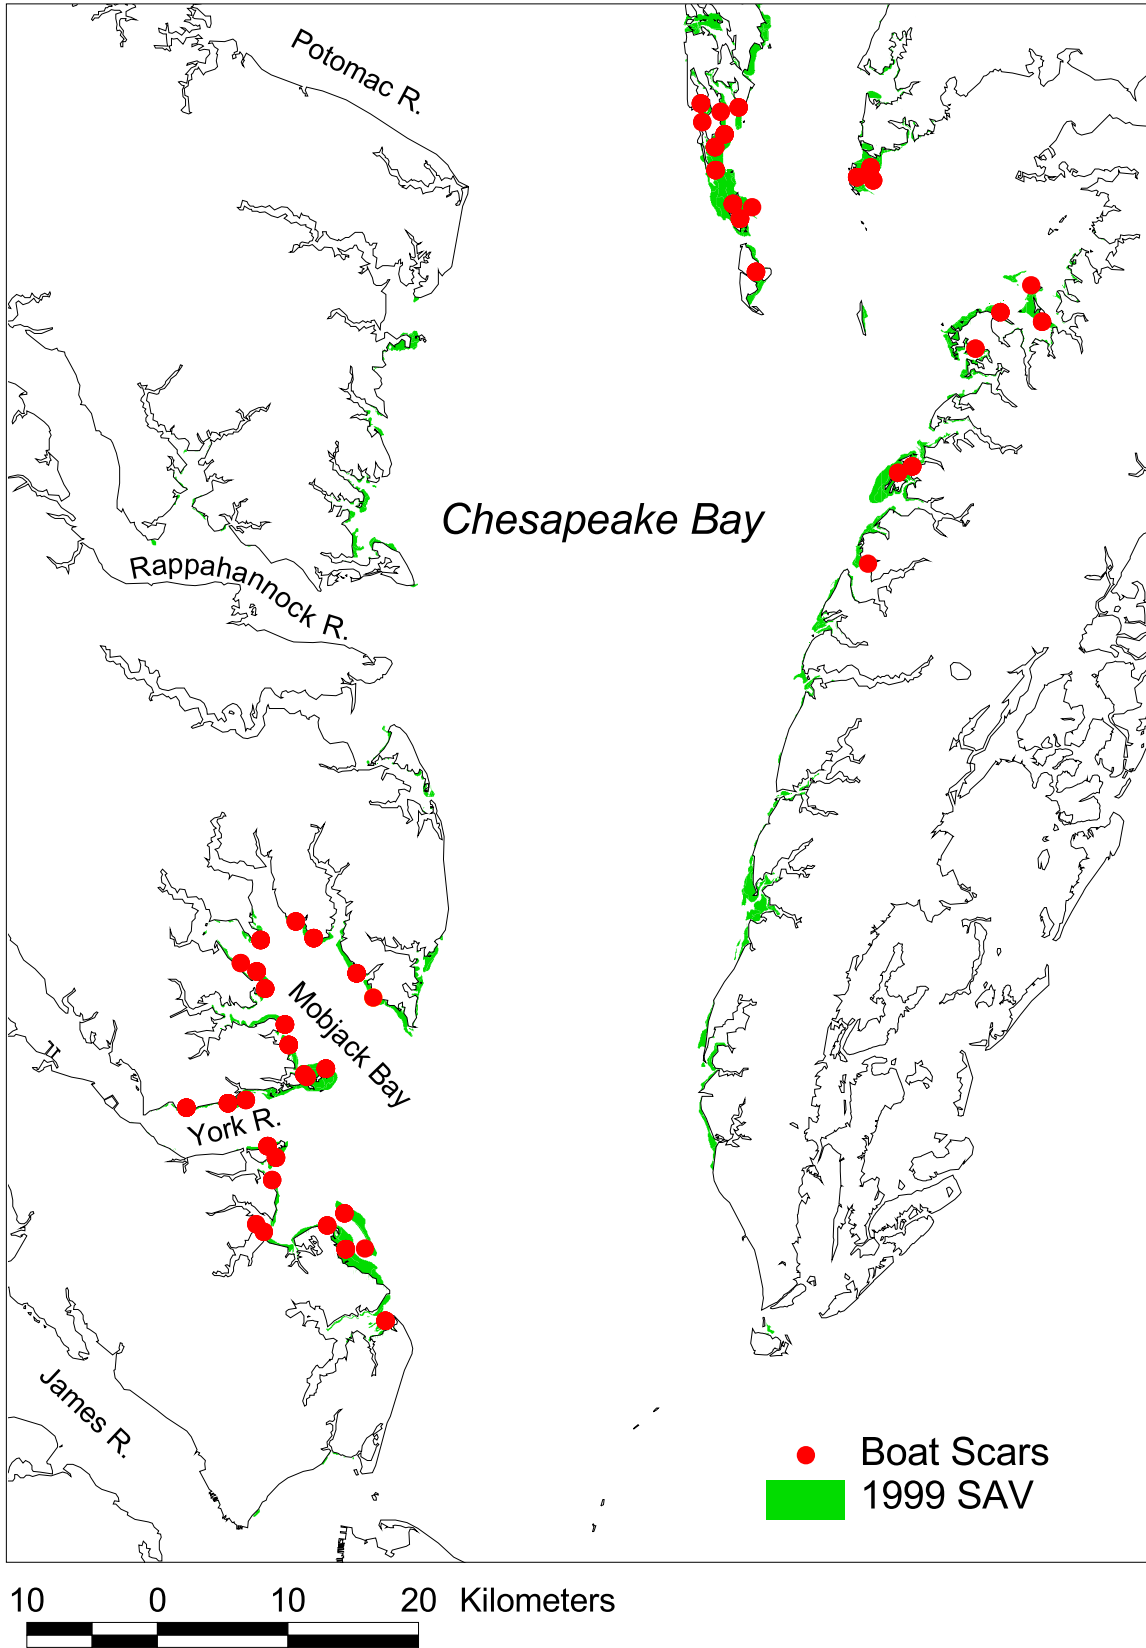
Figure 3: Boat Scars 1987-2000

Figure 3) Map of scarred sites in Virginia (1987-2000)

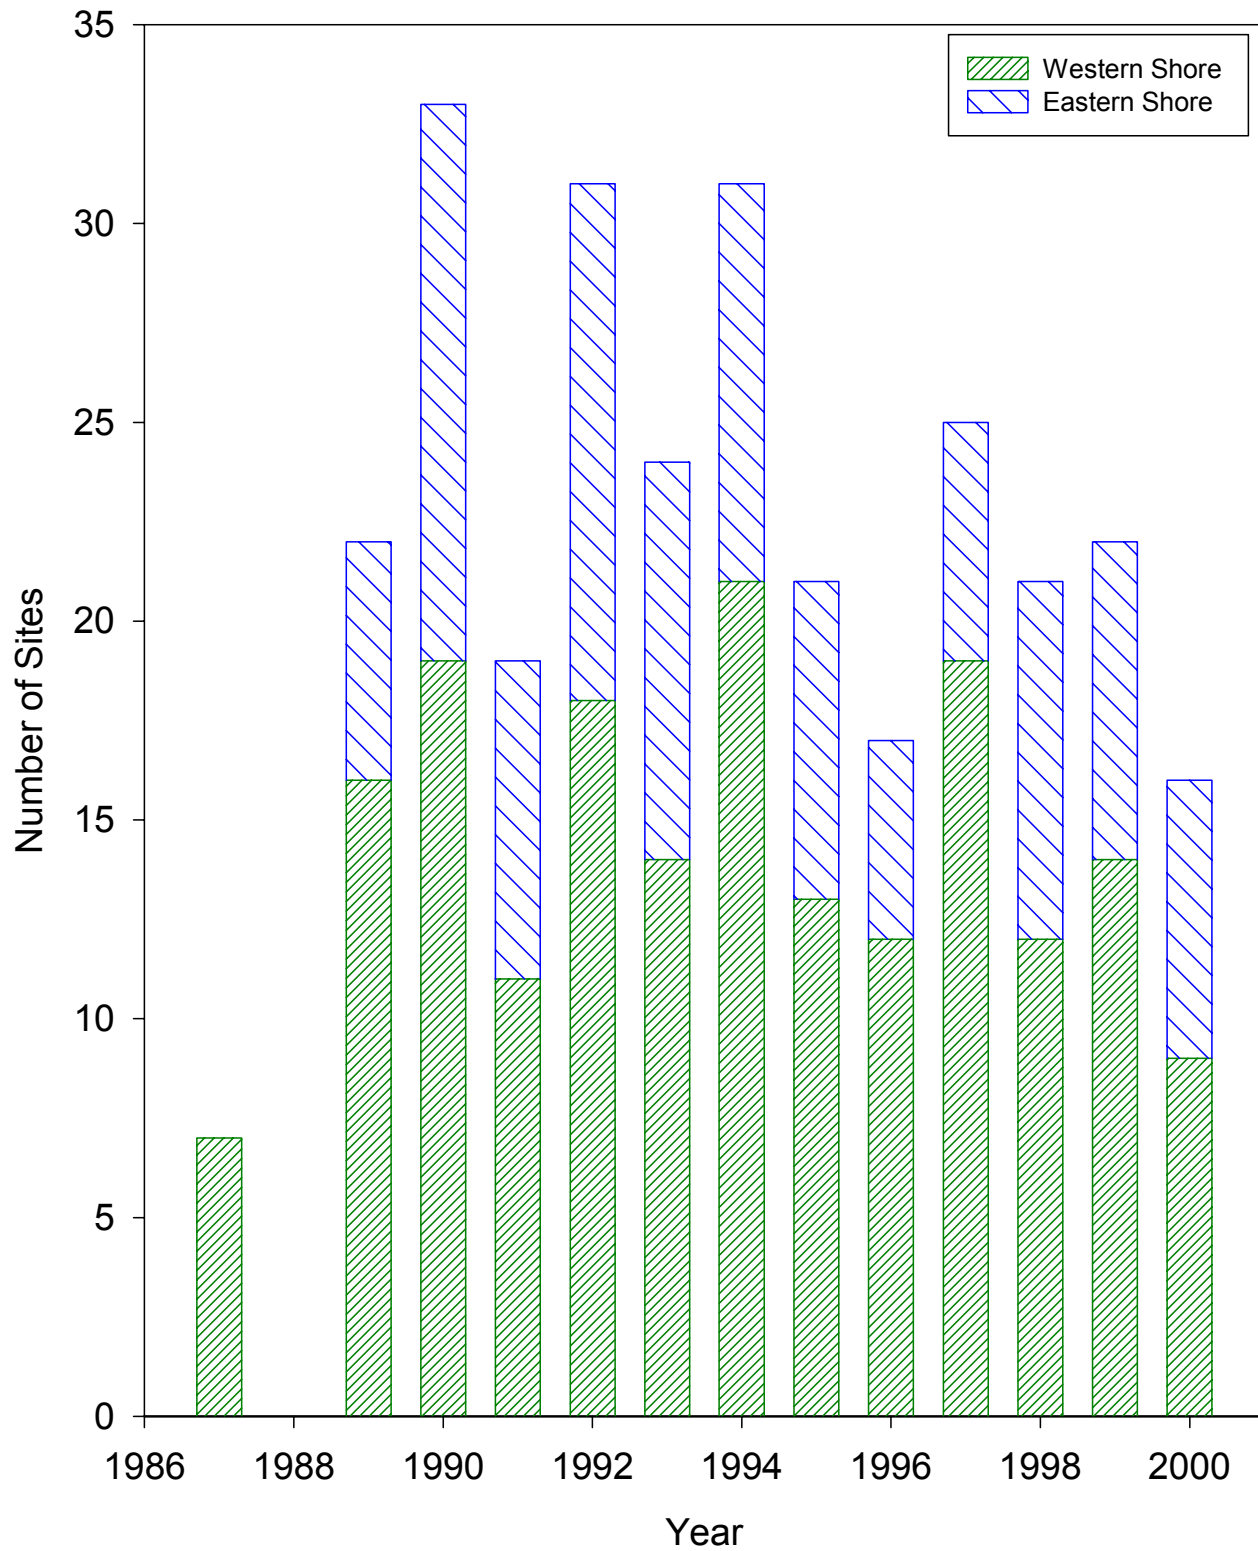
Figure 4: Number of Scarred Sites (1987-2000)

Figure 4) Number of sites scarred each year on the eastern and western shores between 1987 and 2000.

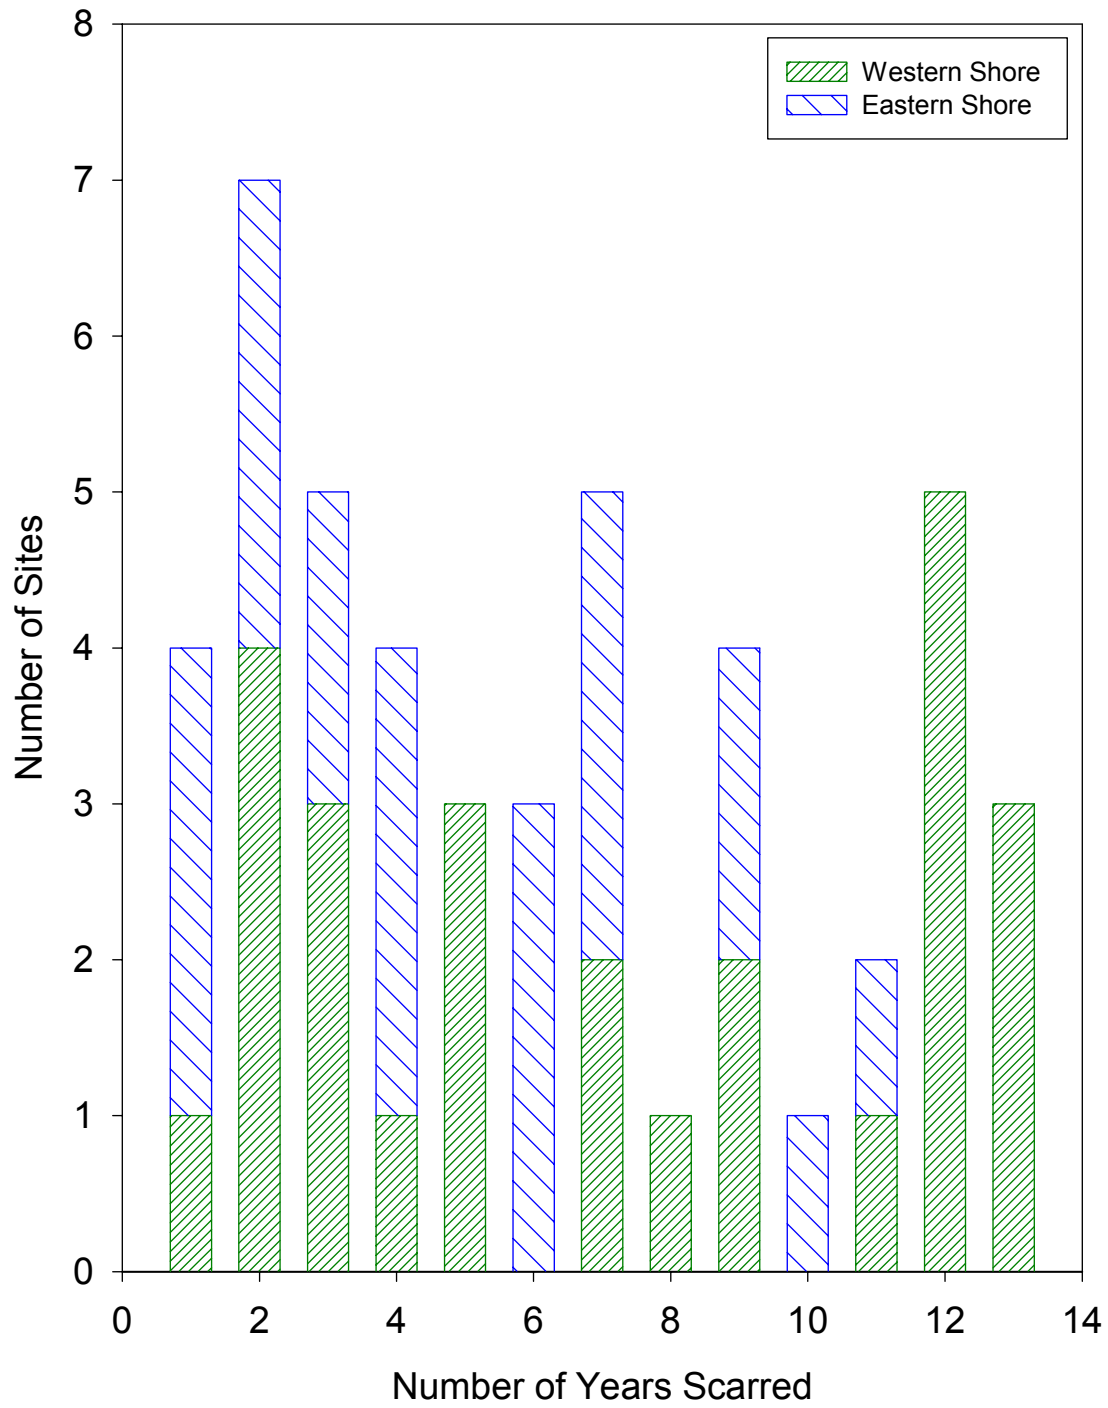
Figure 5: Number of Years Scarred

Figure 5) Frequency of scarring at all sites between 1987 and 2000.

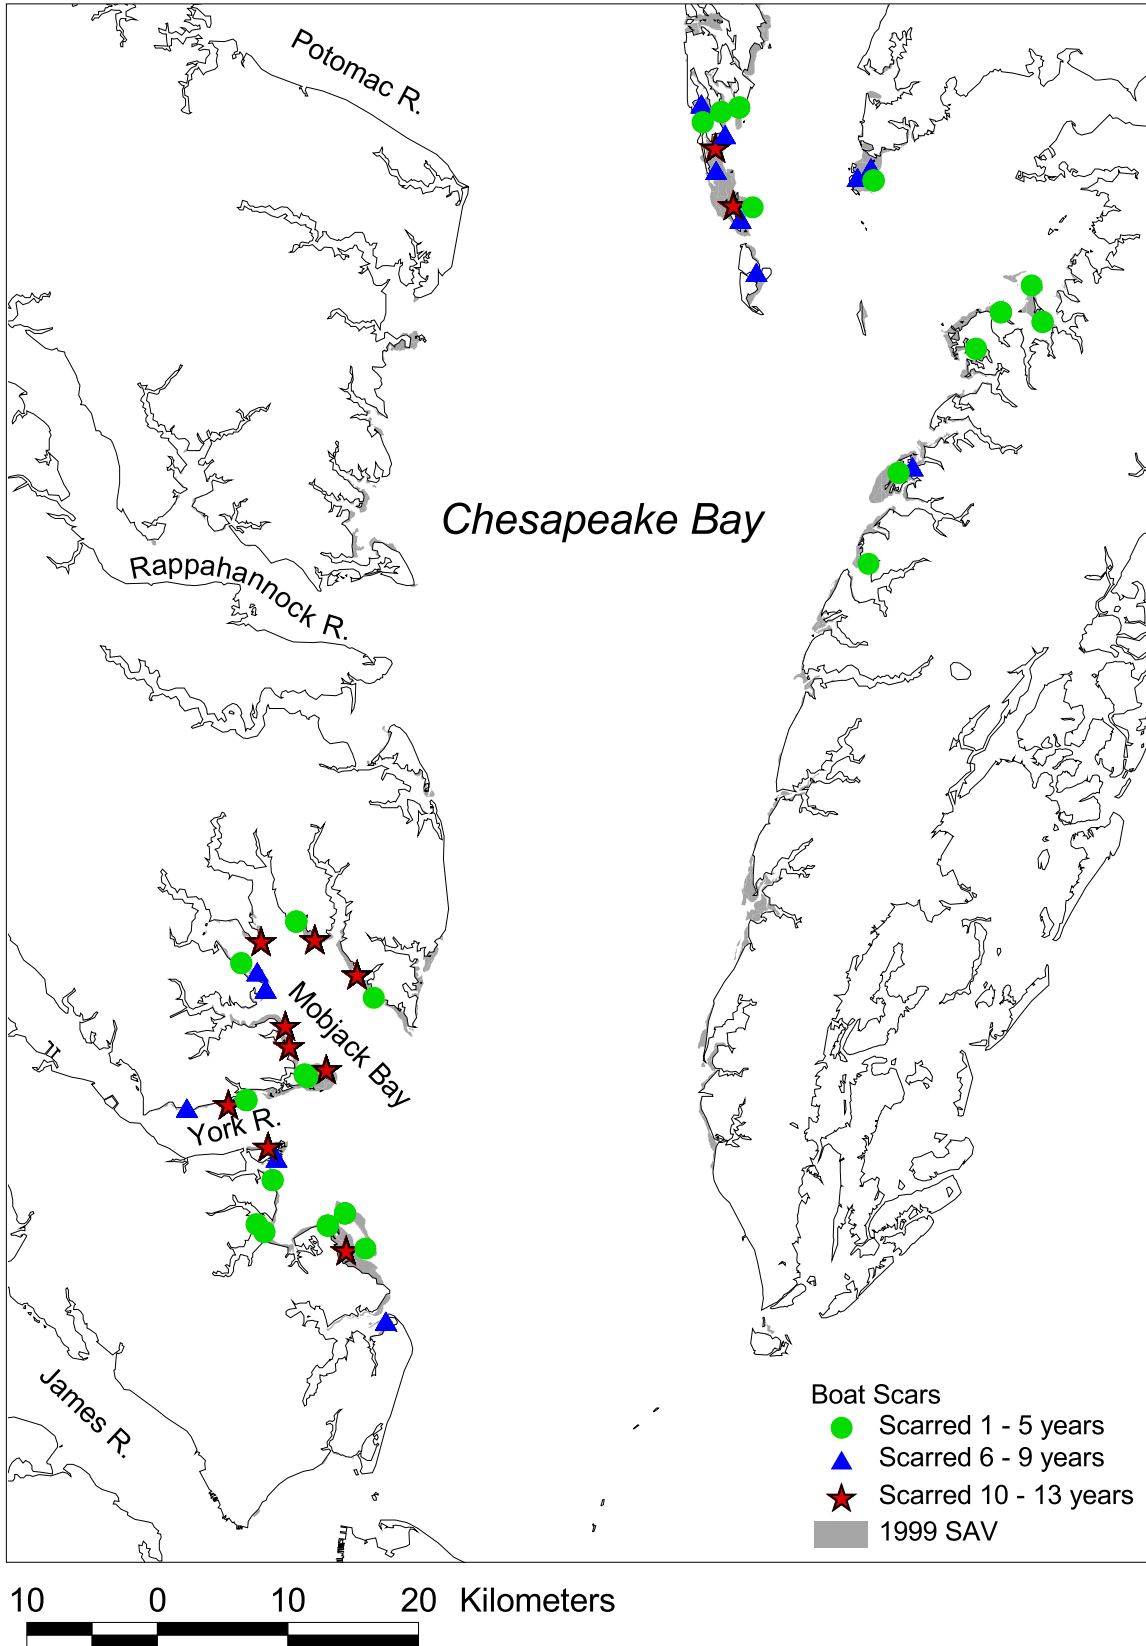
Figure 6: Frequency of Scarring

Figure 6) Locations of sites scarred at various frequencies between 1987 and 2000.

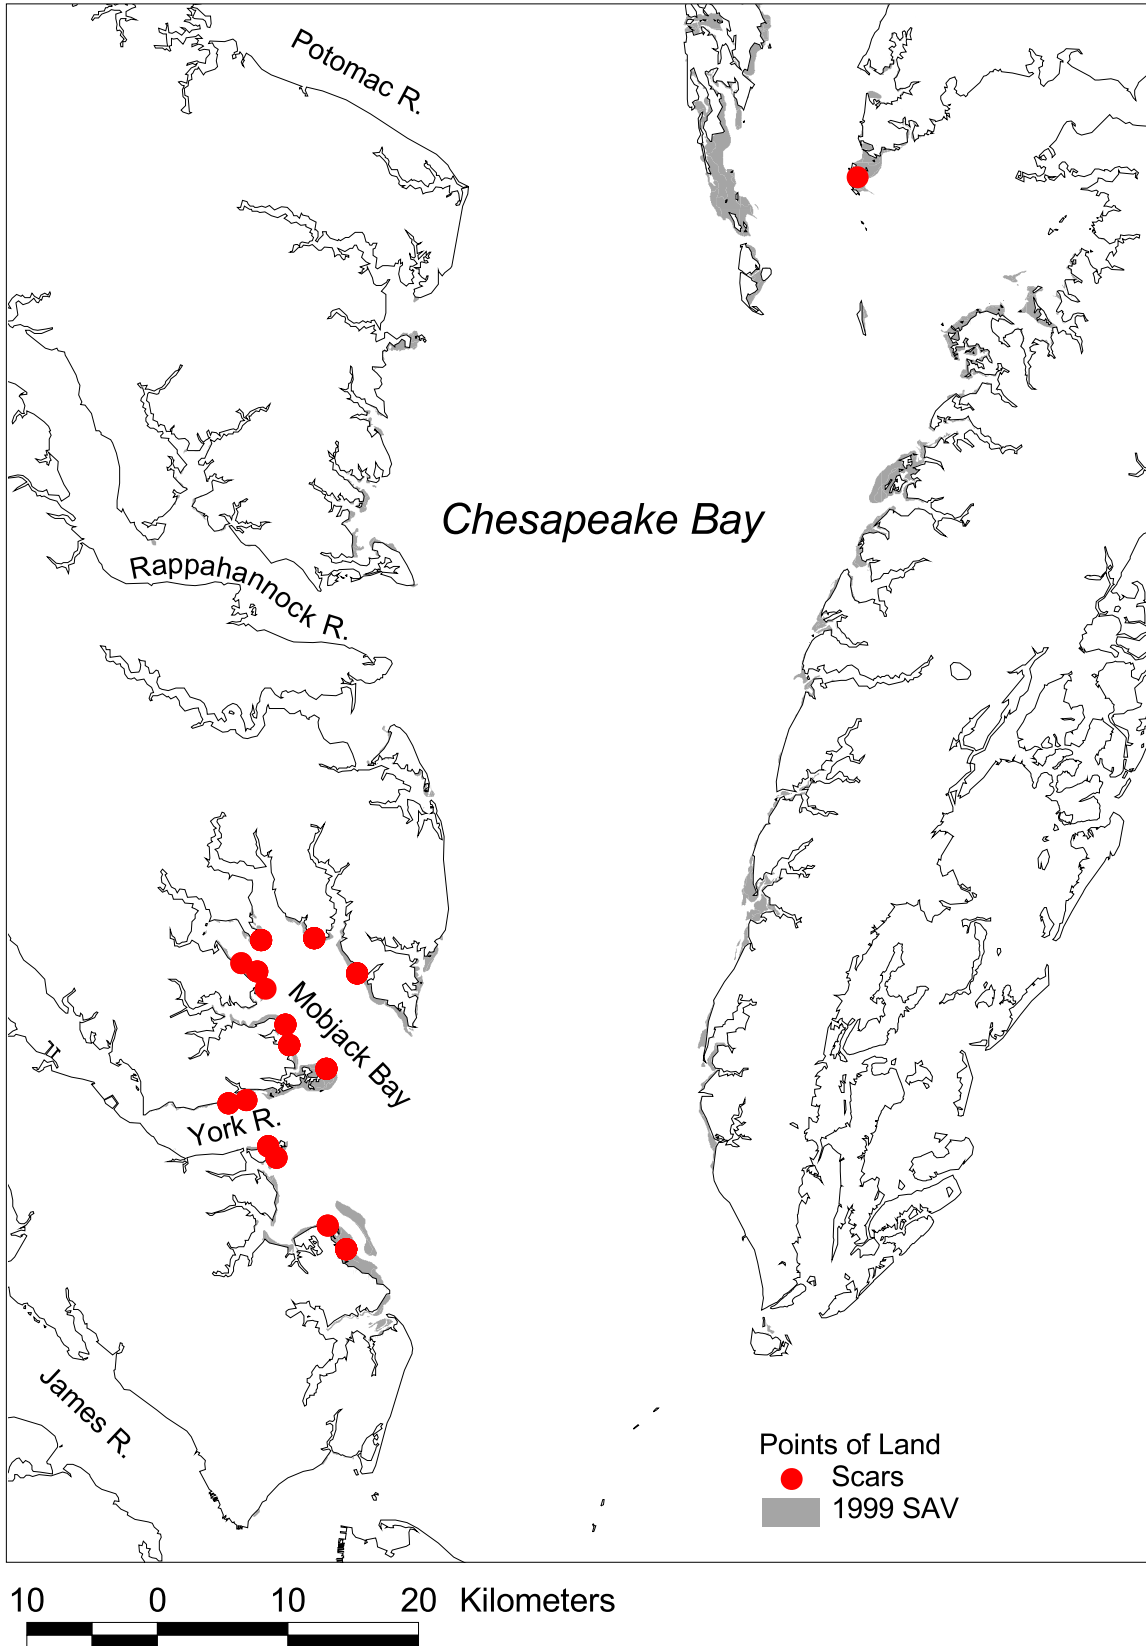
Figure 7: Sites with Scars Associated with Points of Land

Figure 7) Map of scarred sites that contain scars associated with points of land, i.e. scars pointing to or from a point of land.

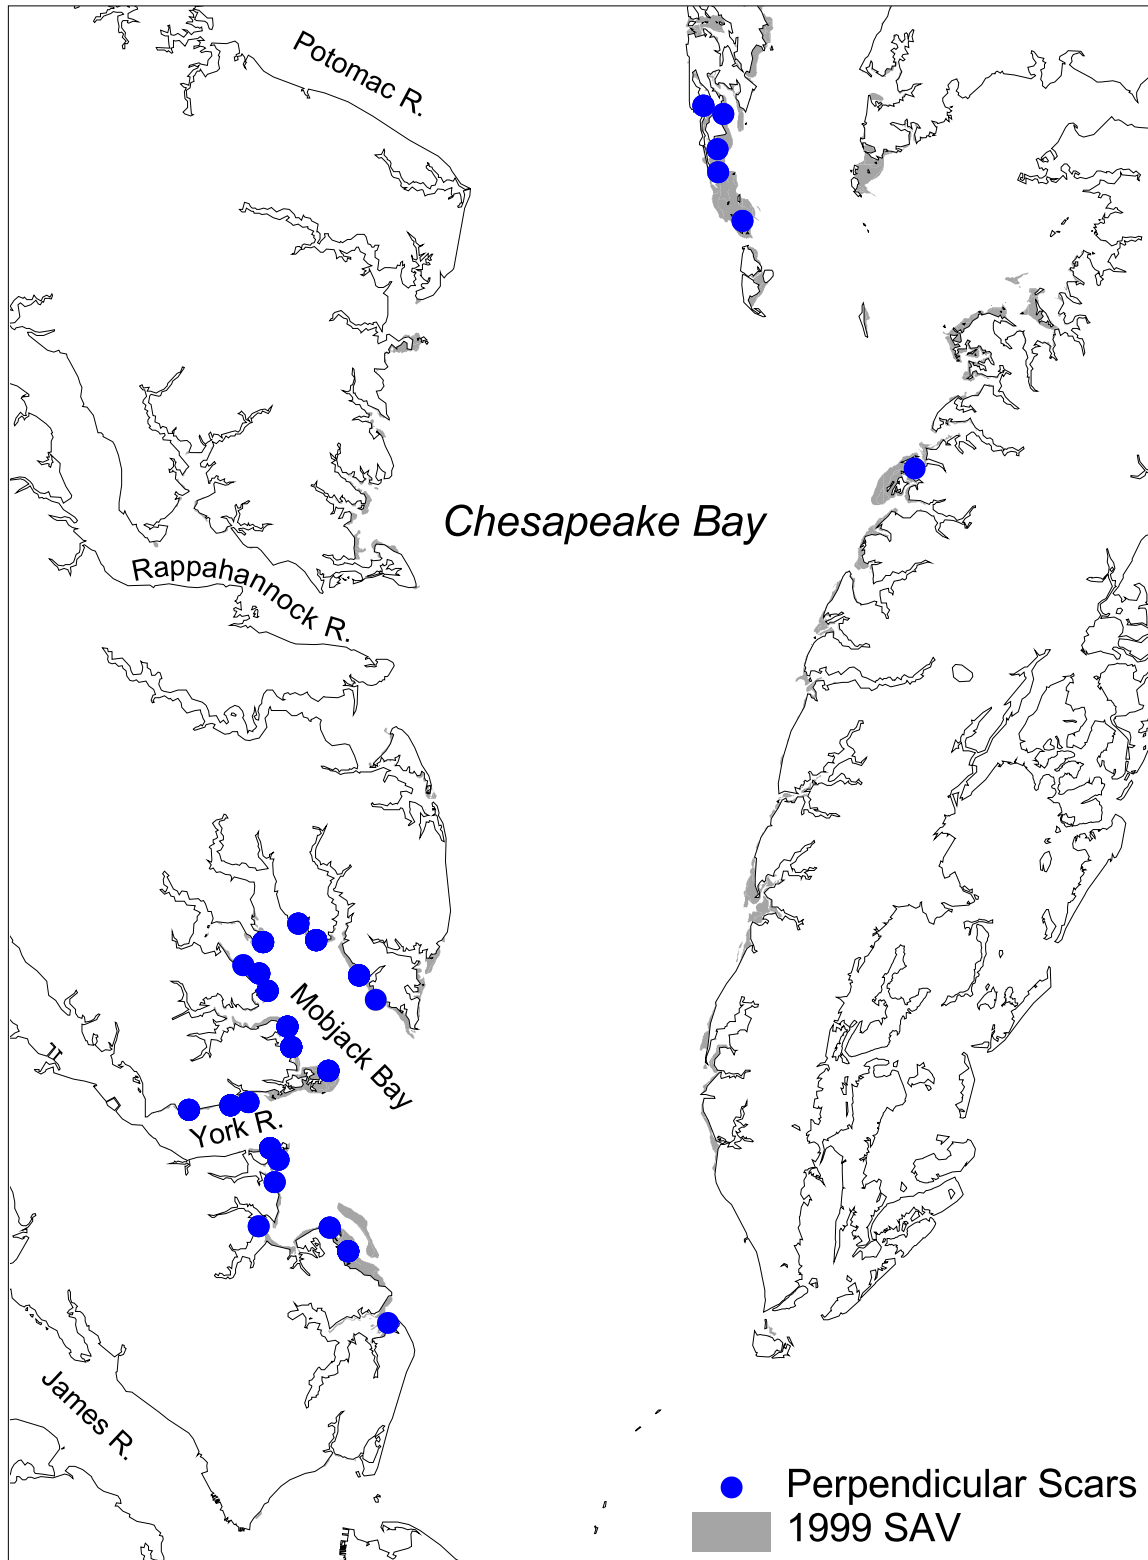
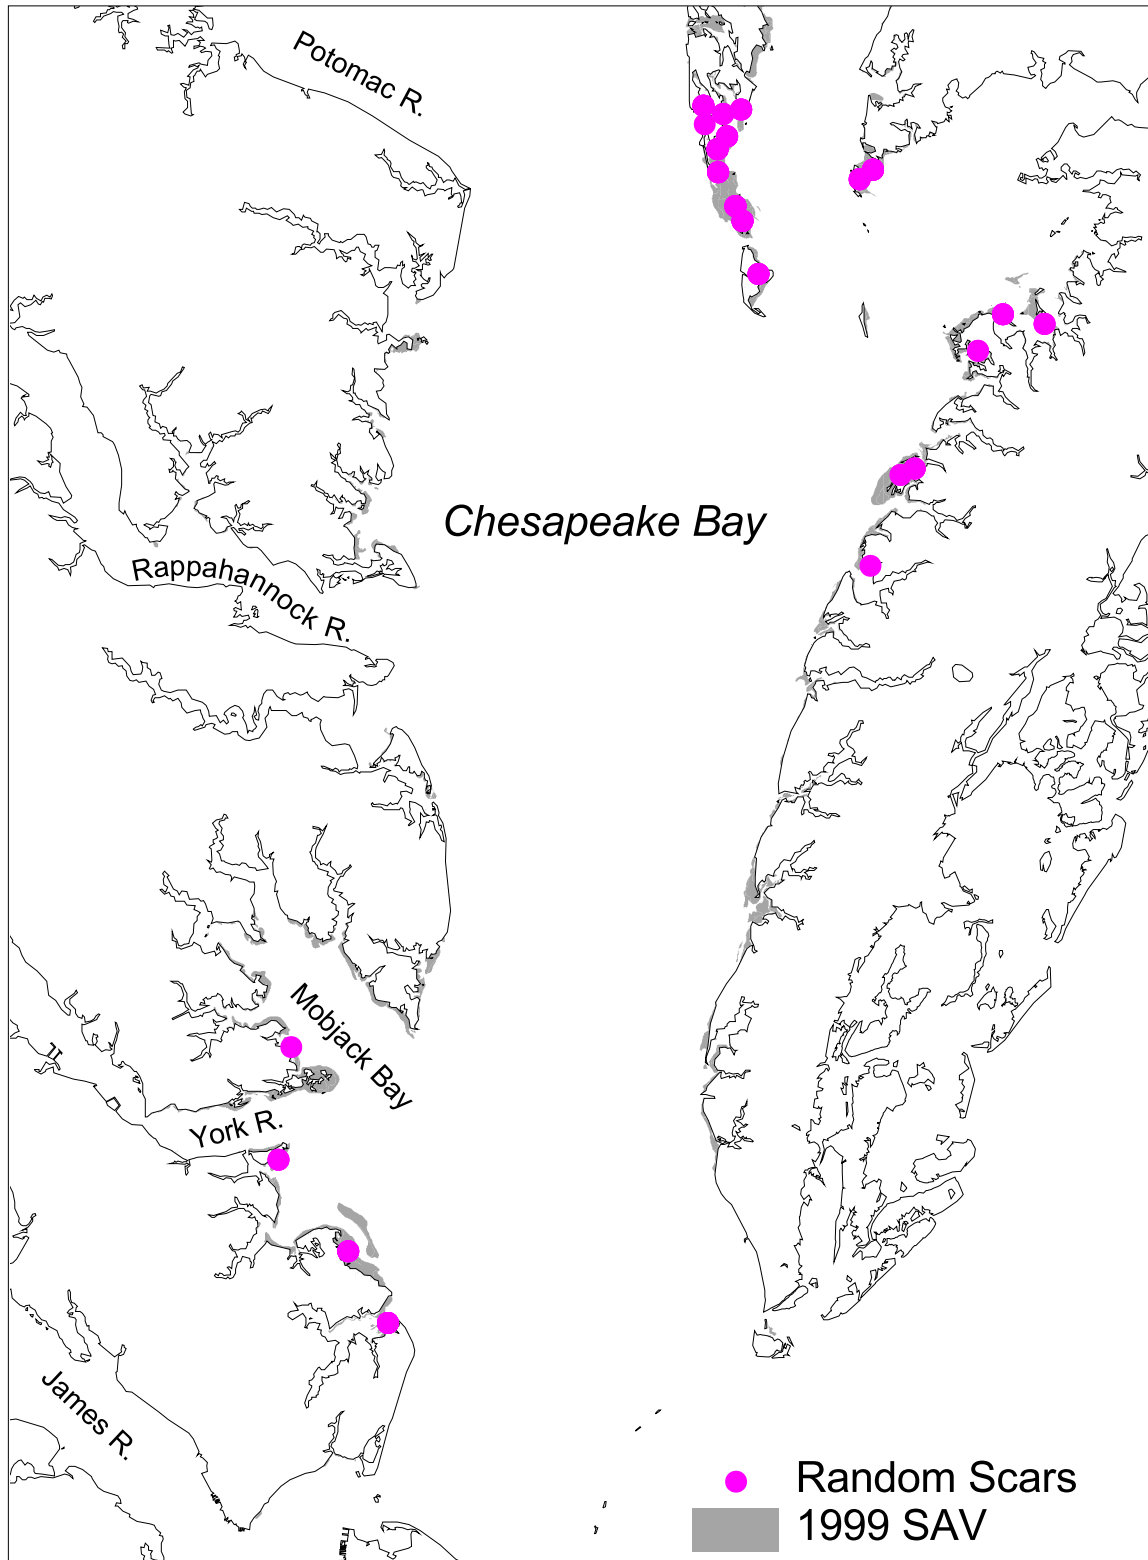
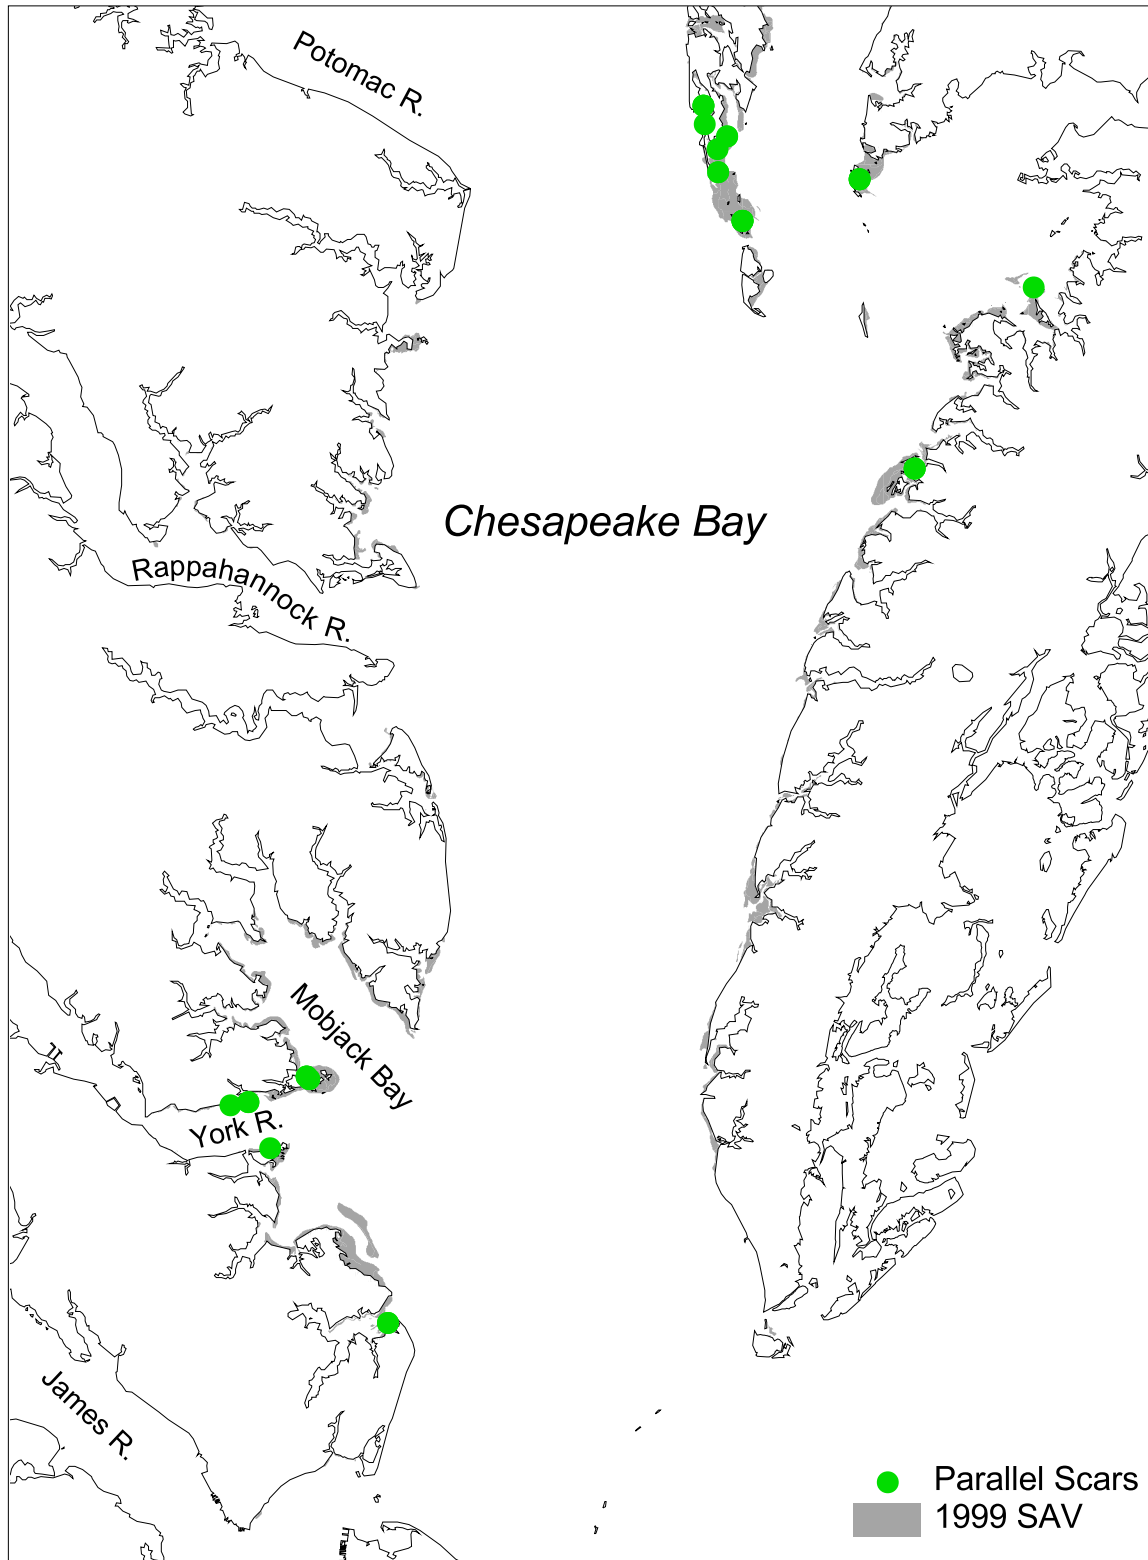
shore (**Figure 8C**). However, scarring is restricted to only certain locations in Virginia, while we believe potting to be ubiquitous throughout Virginia (personal observation, as potting was not part of the VMRC survey). Therefore, we believe that potting is not a primary cause of boat scarring.

Figure 8) A) Map of scarred sites that contain scars oriented perpendicular to shore. B) Sites that contain scars oriented randomly relative to the shoreline. C) Sites that contain scars oriented parallel to the shoreline.

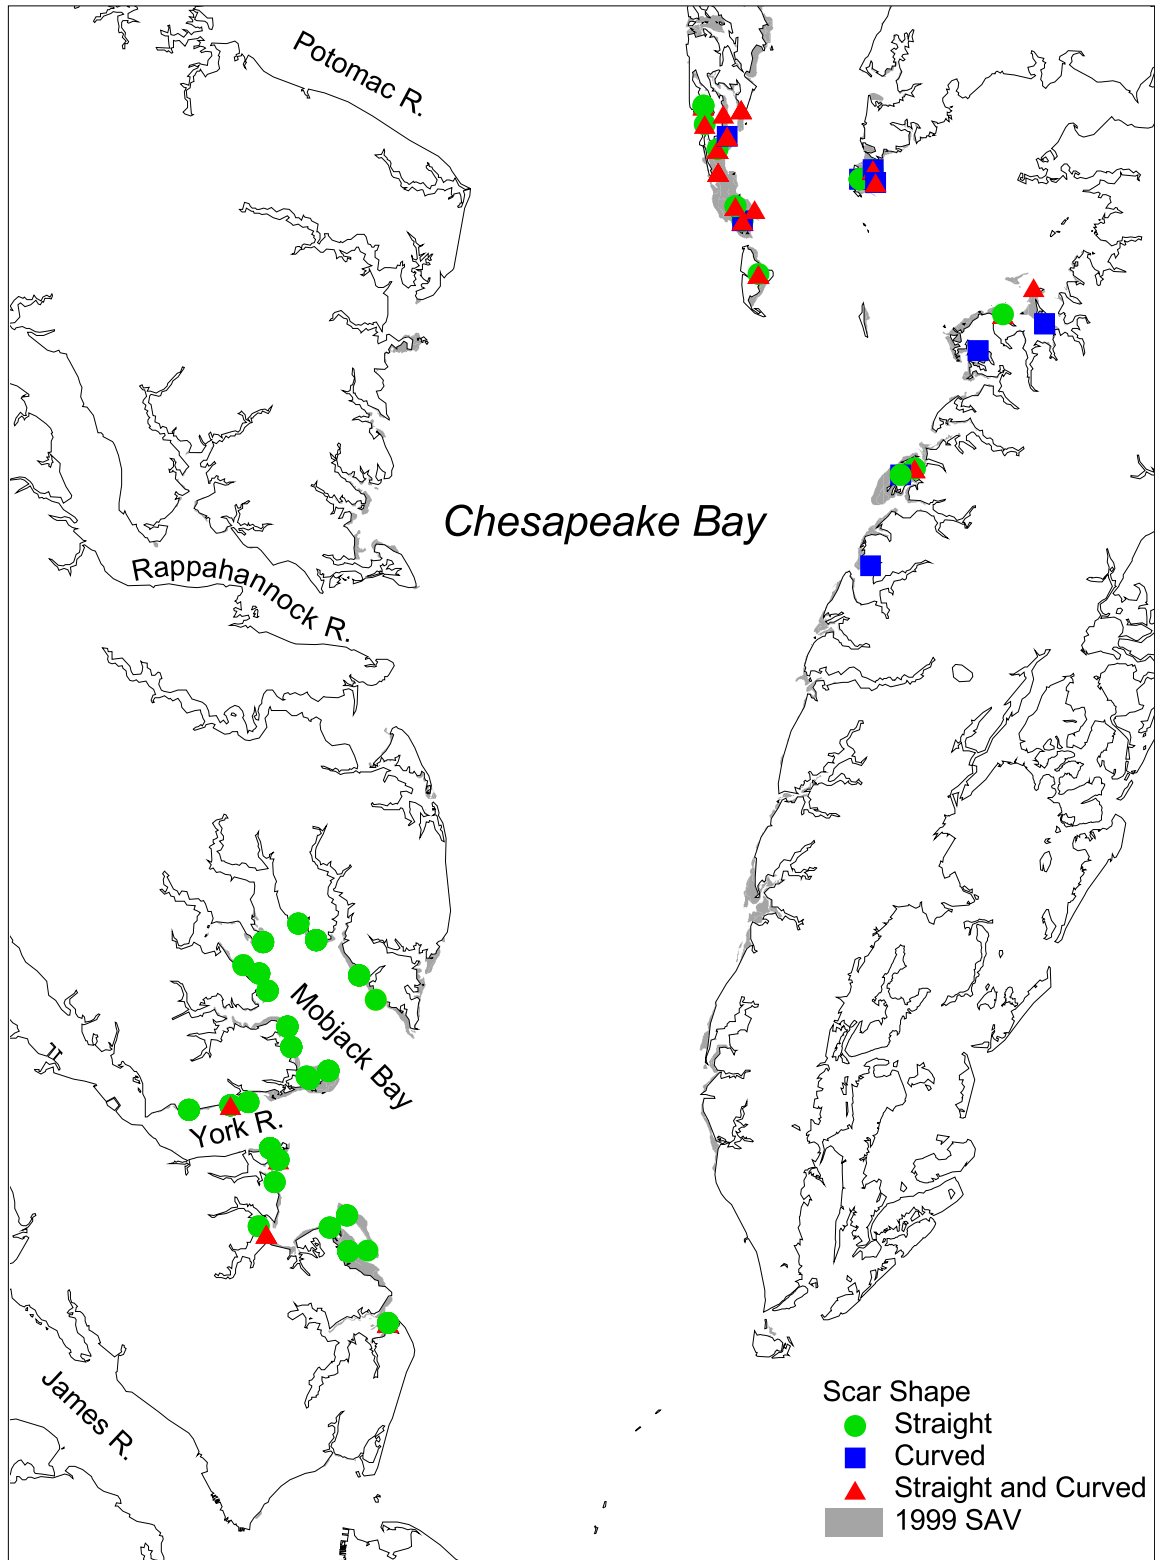
Figure 9: Scar Curvature

Figure 9) Map of scarred sites that contain scars that are in straight lines, curved in shape, or both.

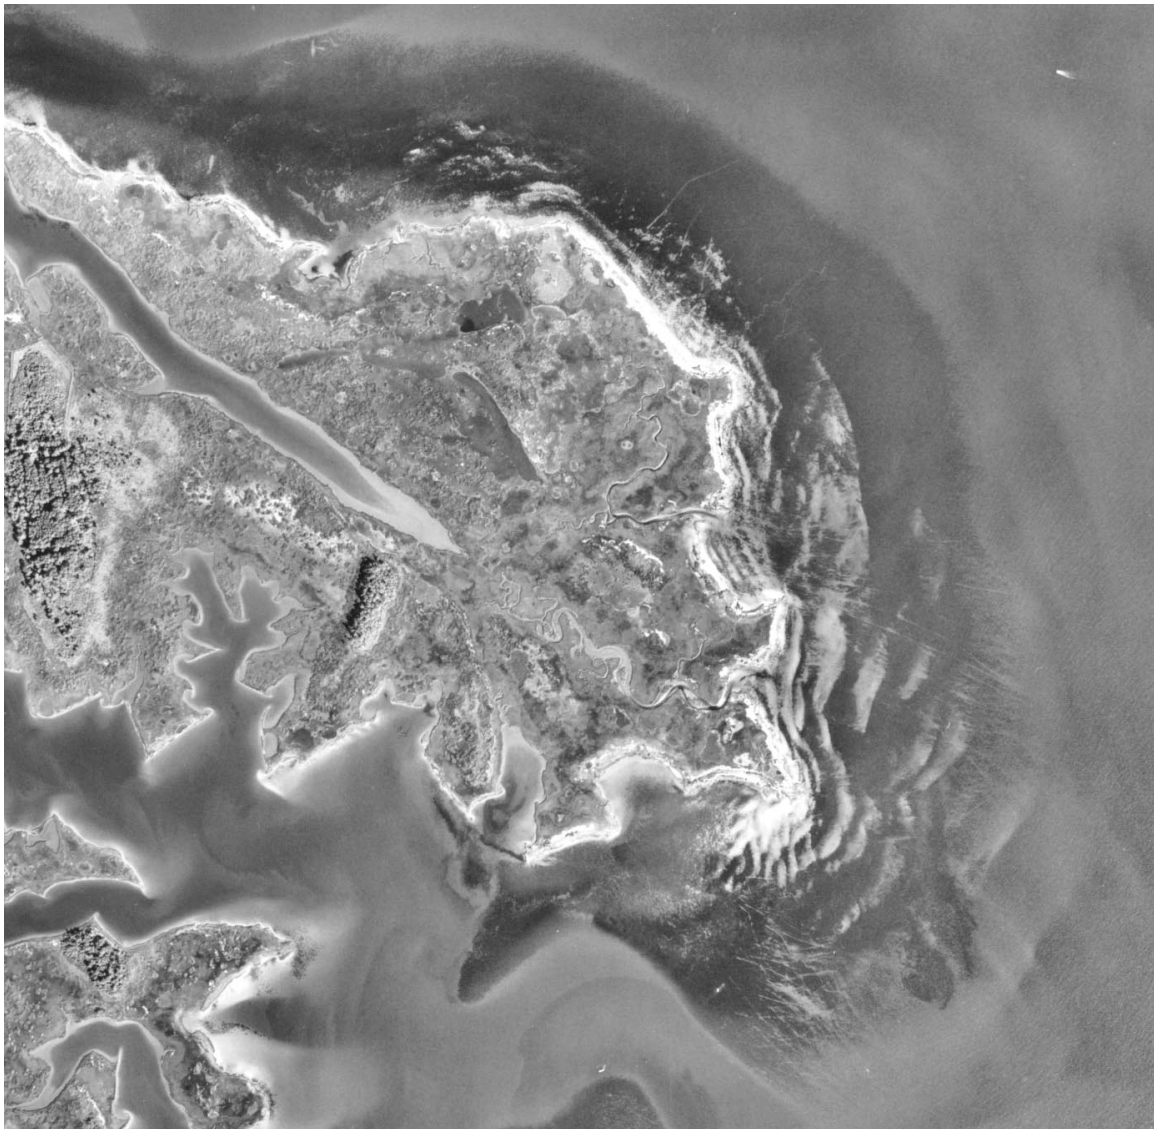
Figure 13: Bush Point, 1992

Figure 13) 1:24,000 scale aerial photograph of Bush Point in 1992.

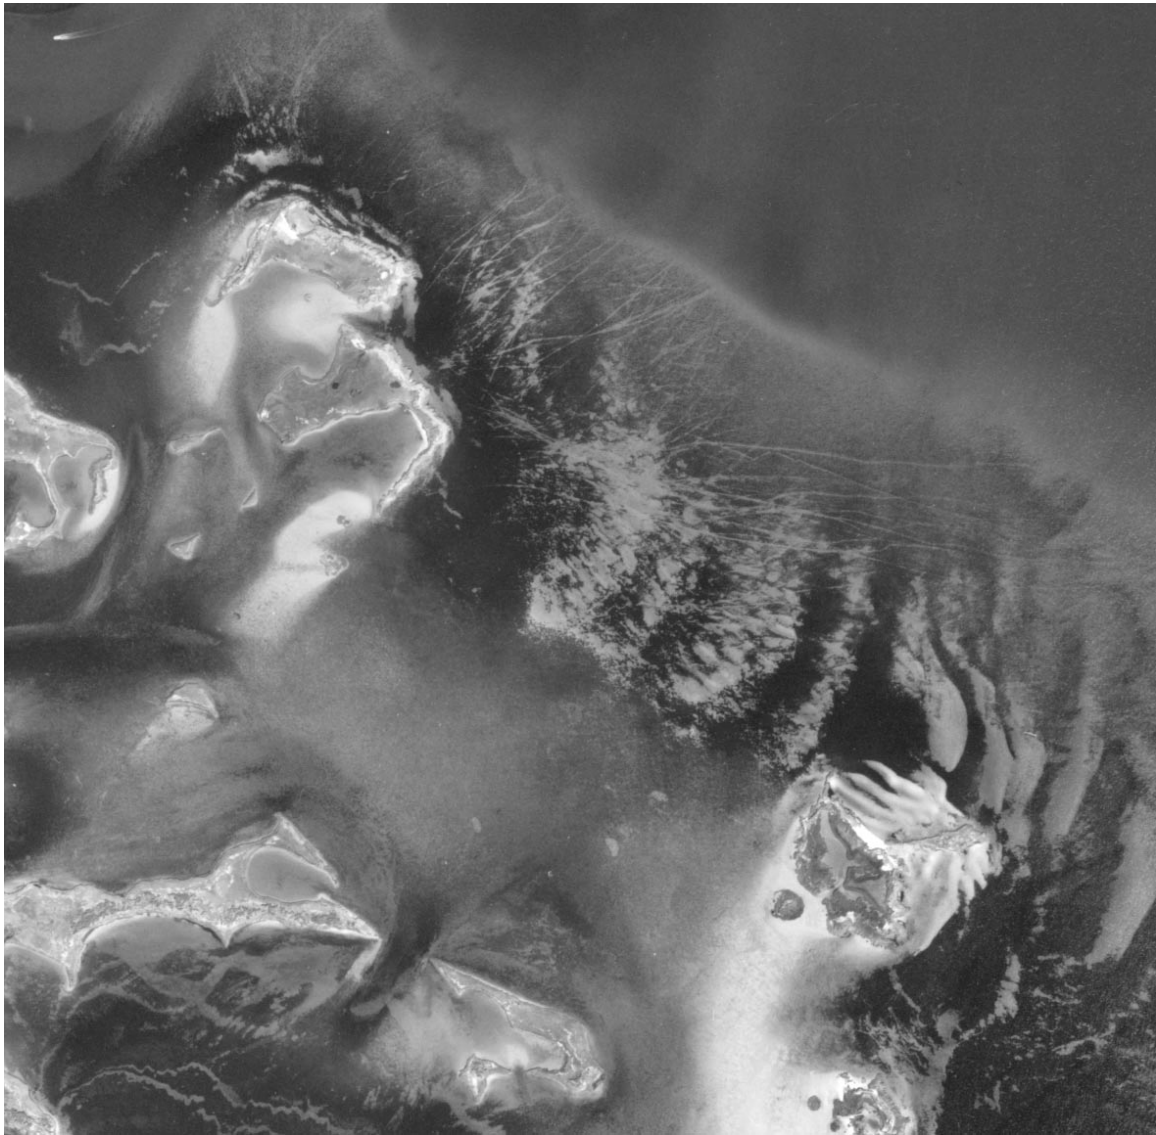
Figure 14: Guinea Marsh, 1990

Figure 14) 1:24,000 scale aerial photograph of Guinea Marsh in 1990.

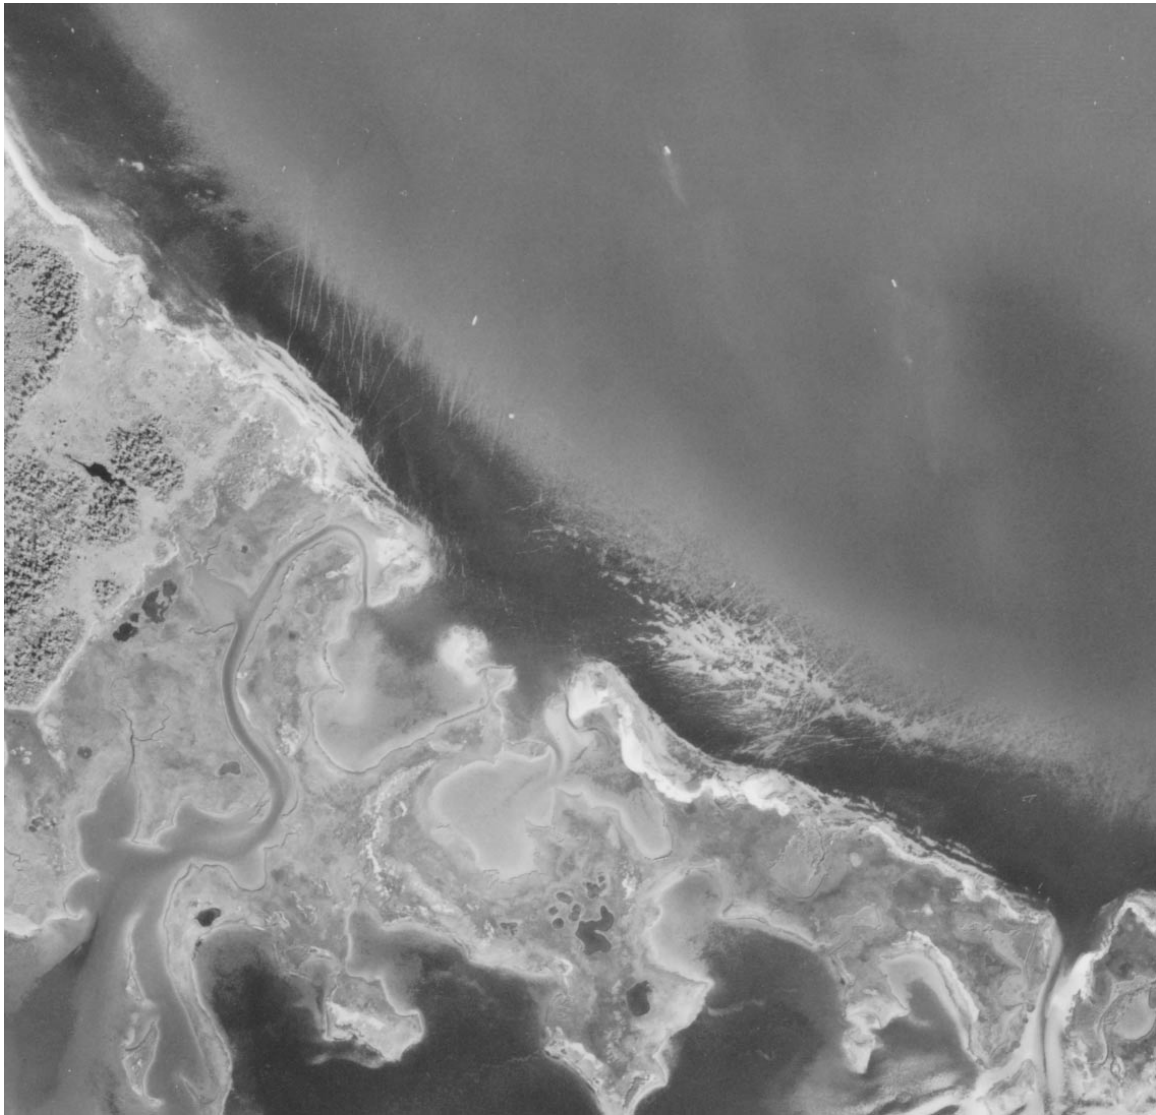
Figure 15: North Shore of Goodwin Island, 1992

Figure 15) 1:24,000 scale aerial photograph of the northern shore of Goodwin Island in 1992.

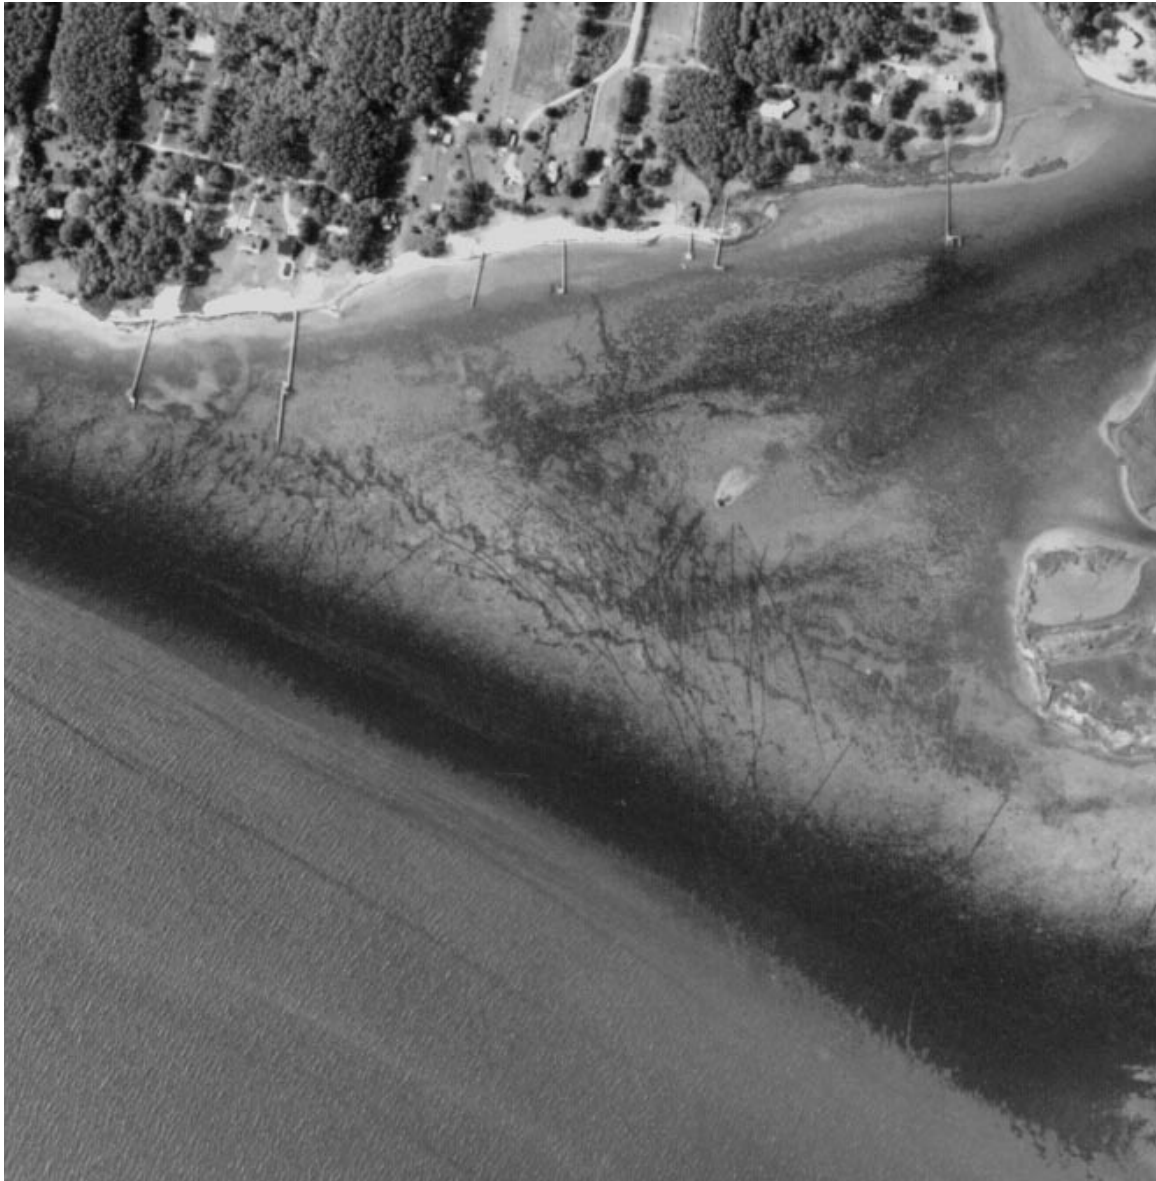
Figure 16: West of Allen's Island, 1997

Figure 16) 1:24,000 scale aerial photograph of the north shore of the York River, west of Allen's Island.

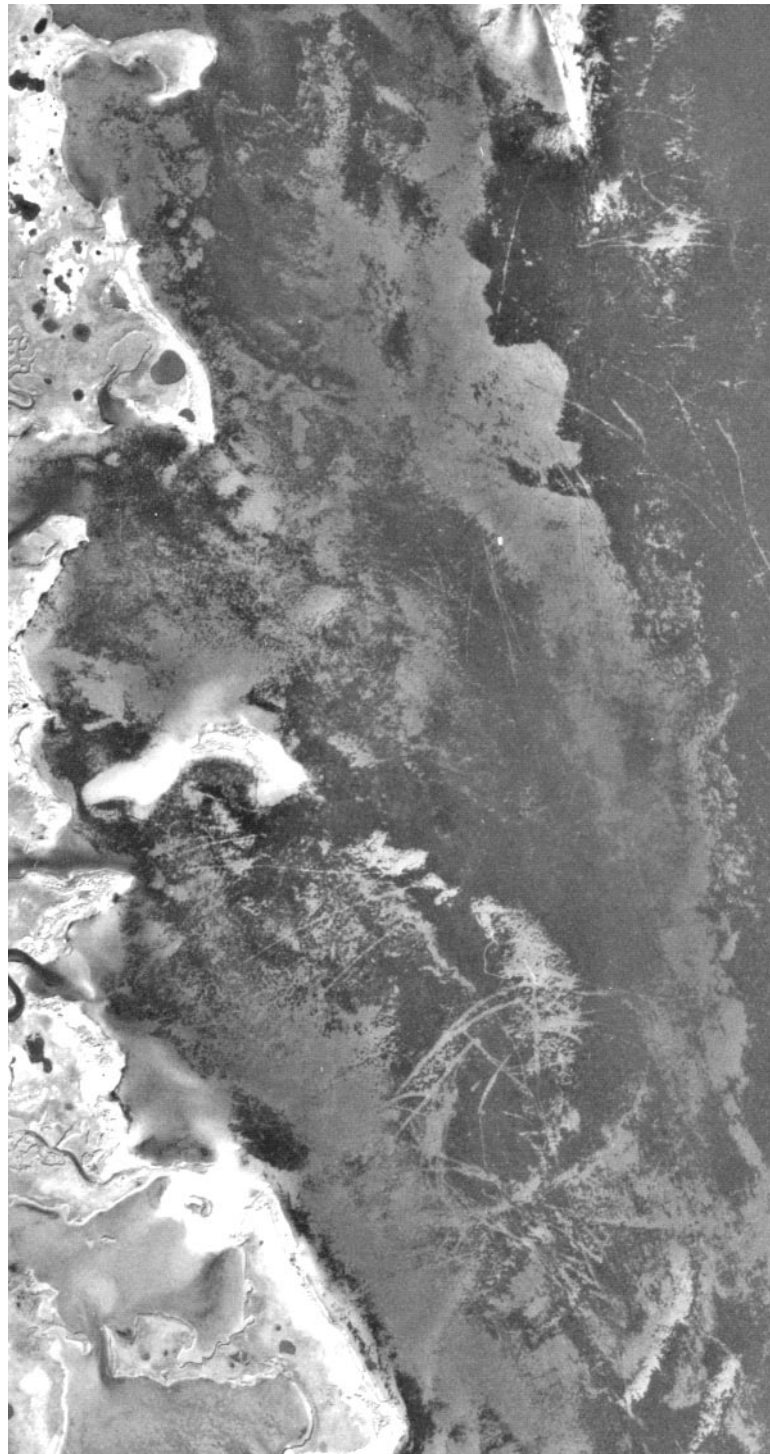
Figure 17: Plum Tree Island, 1998

Figure 17) 1:24,000 scale aerial photograph of Plum Tree Island in 1998.
