**Boat Scarring Effects on
Submerged Aquatic Vegetation in Virginia
(Year 1)**

Final Report to the Virginia Saltwater Recreational Fishing Development Fund
Virginia Marine Resources Commission
Newport News, Virginia

October, 2001

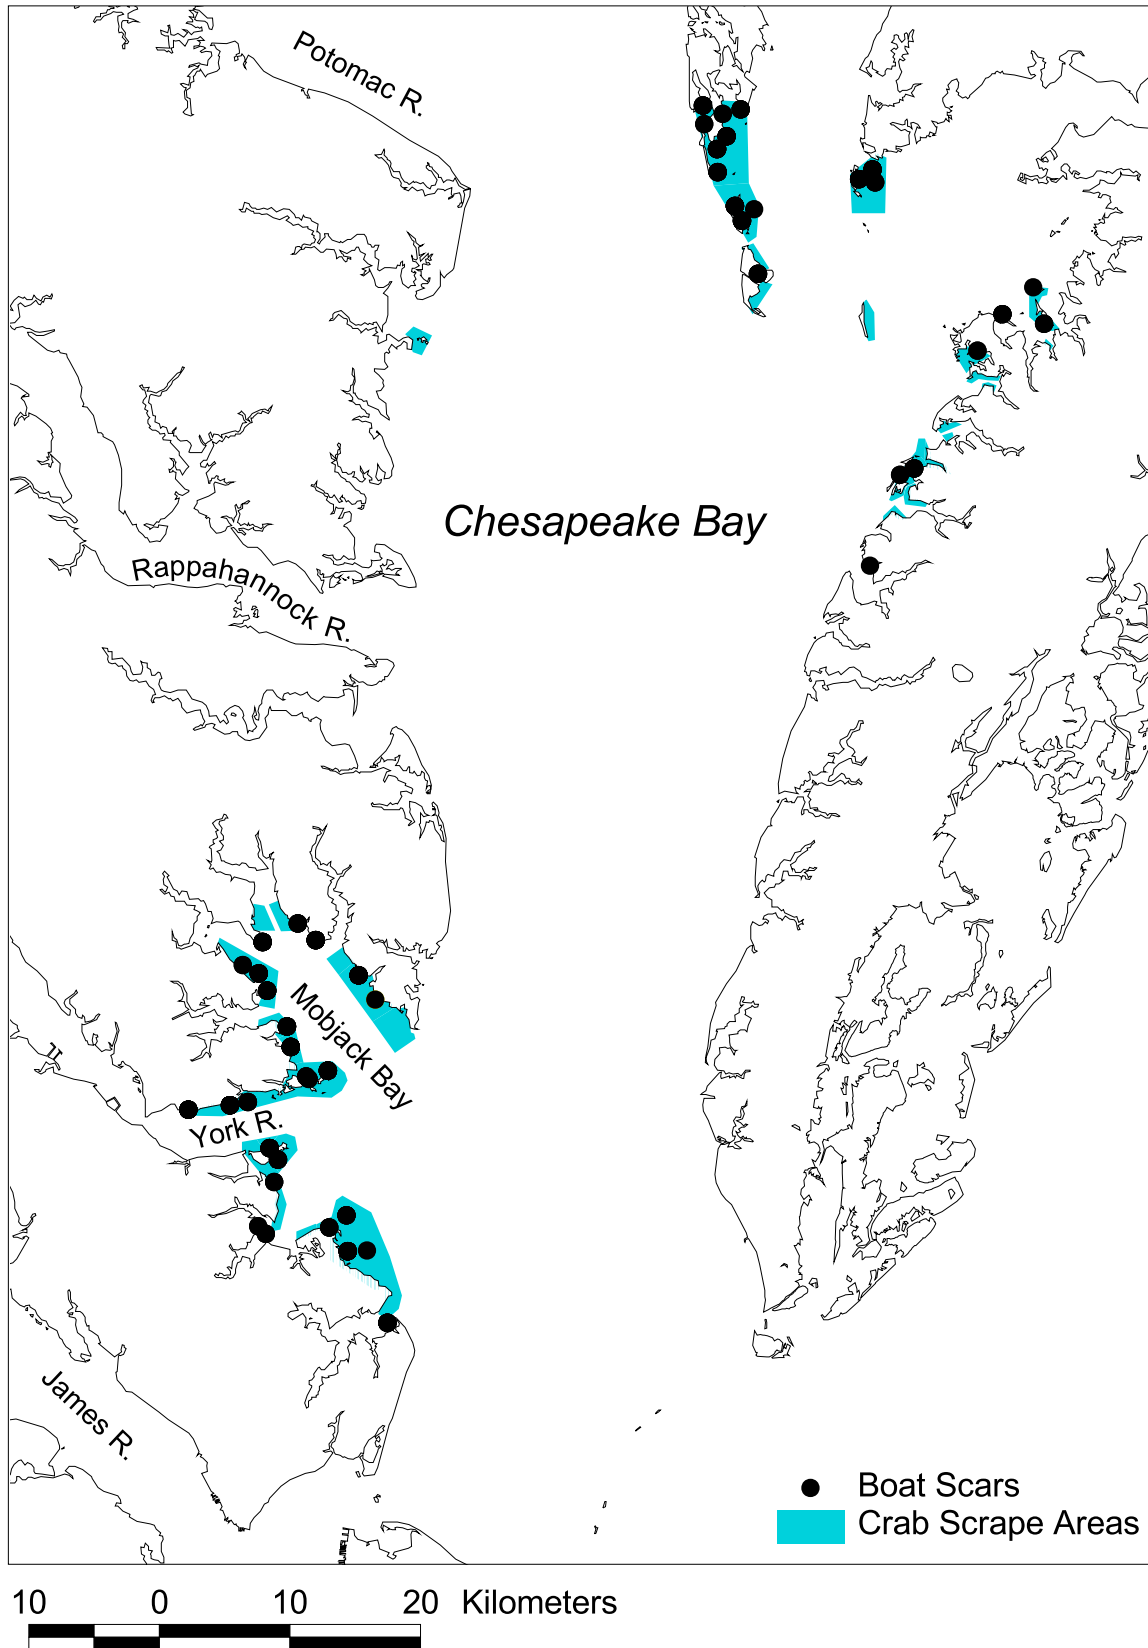
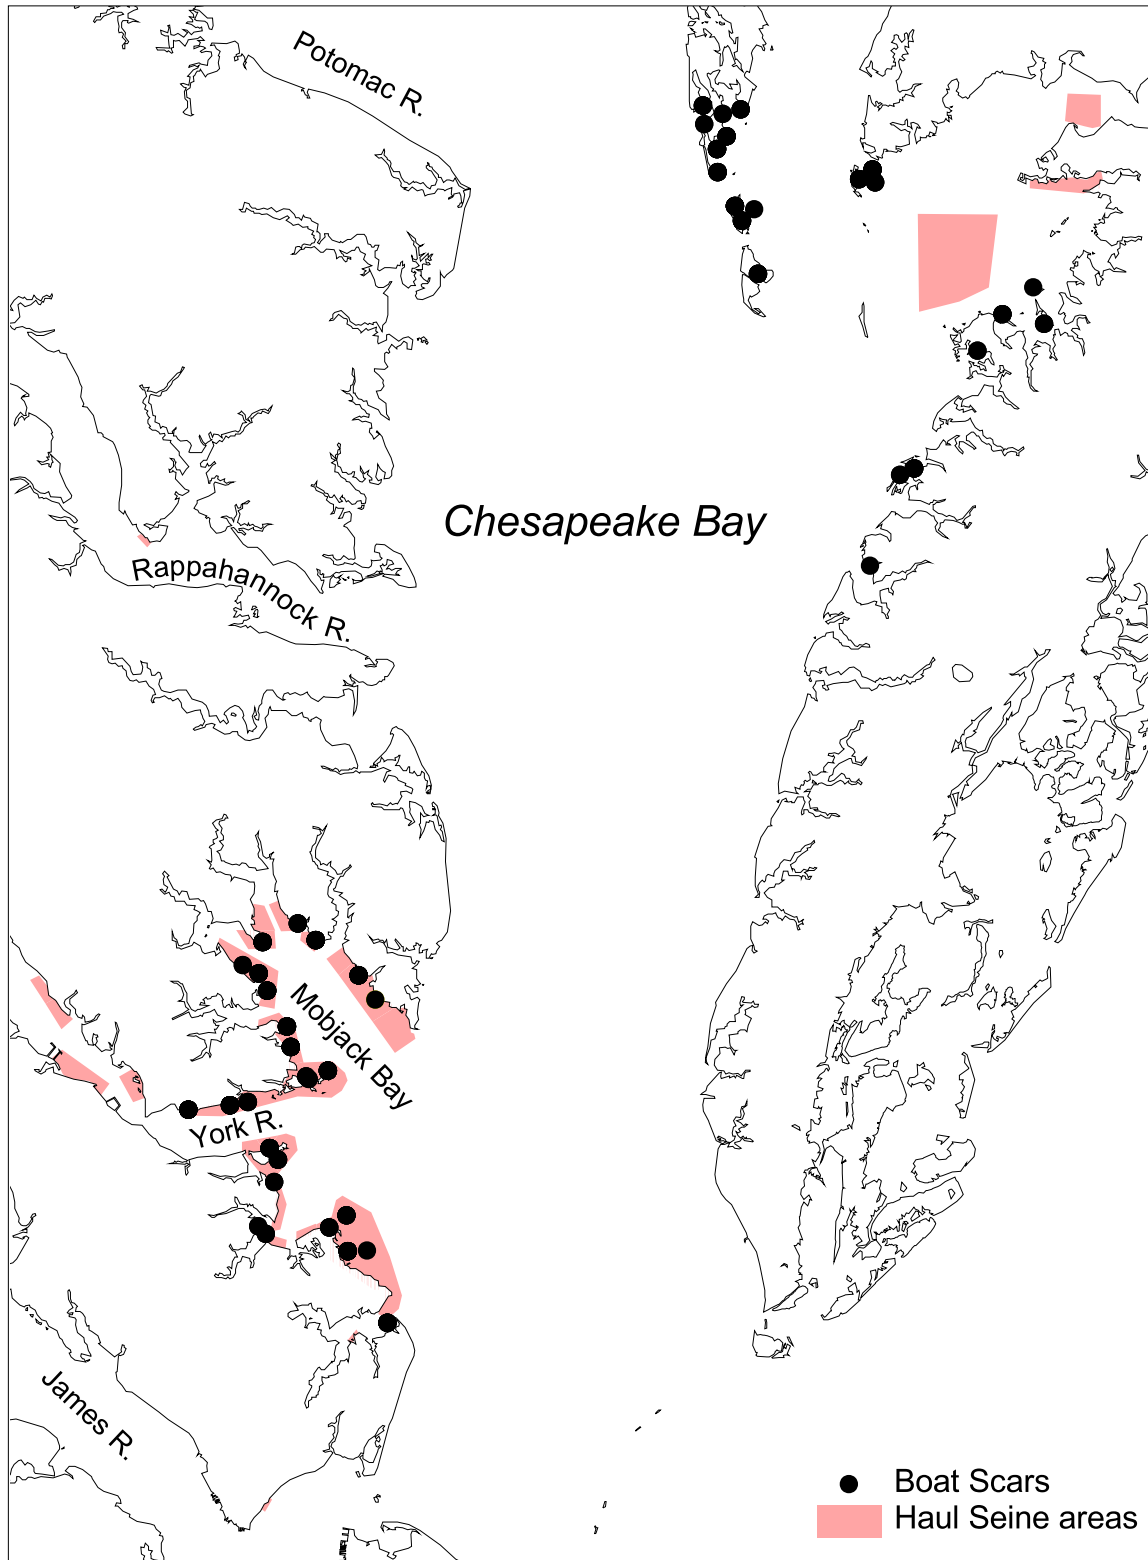
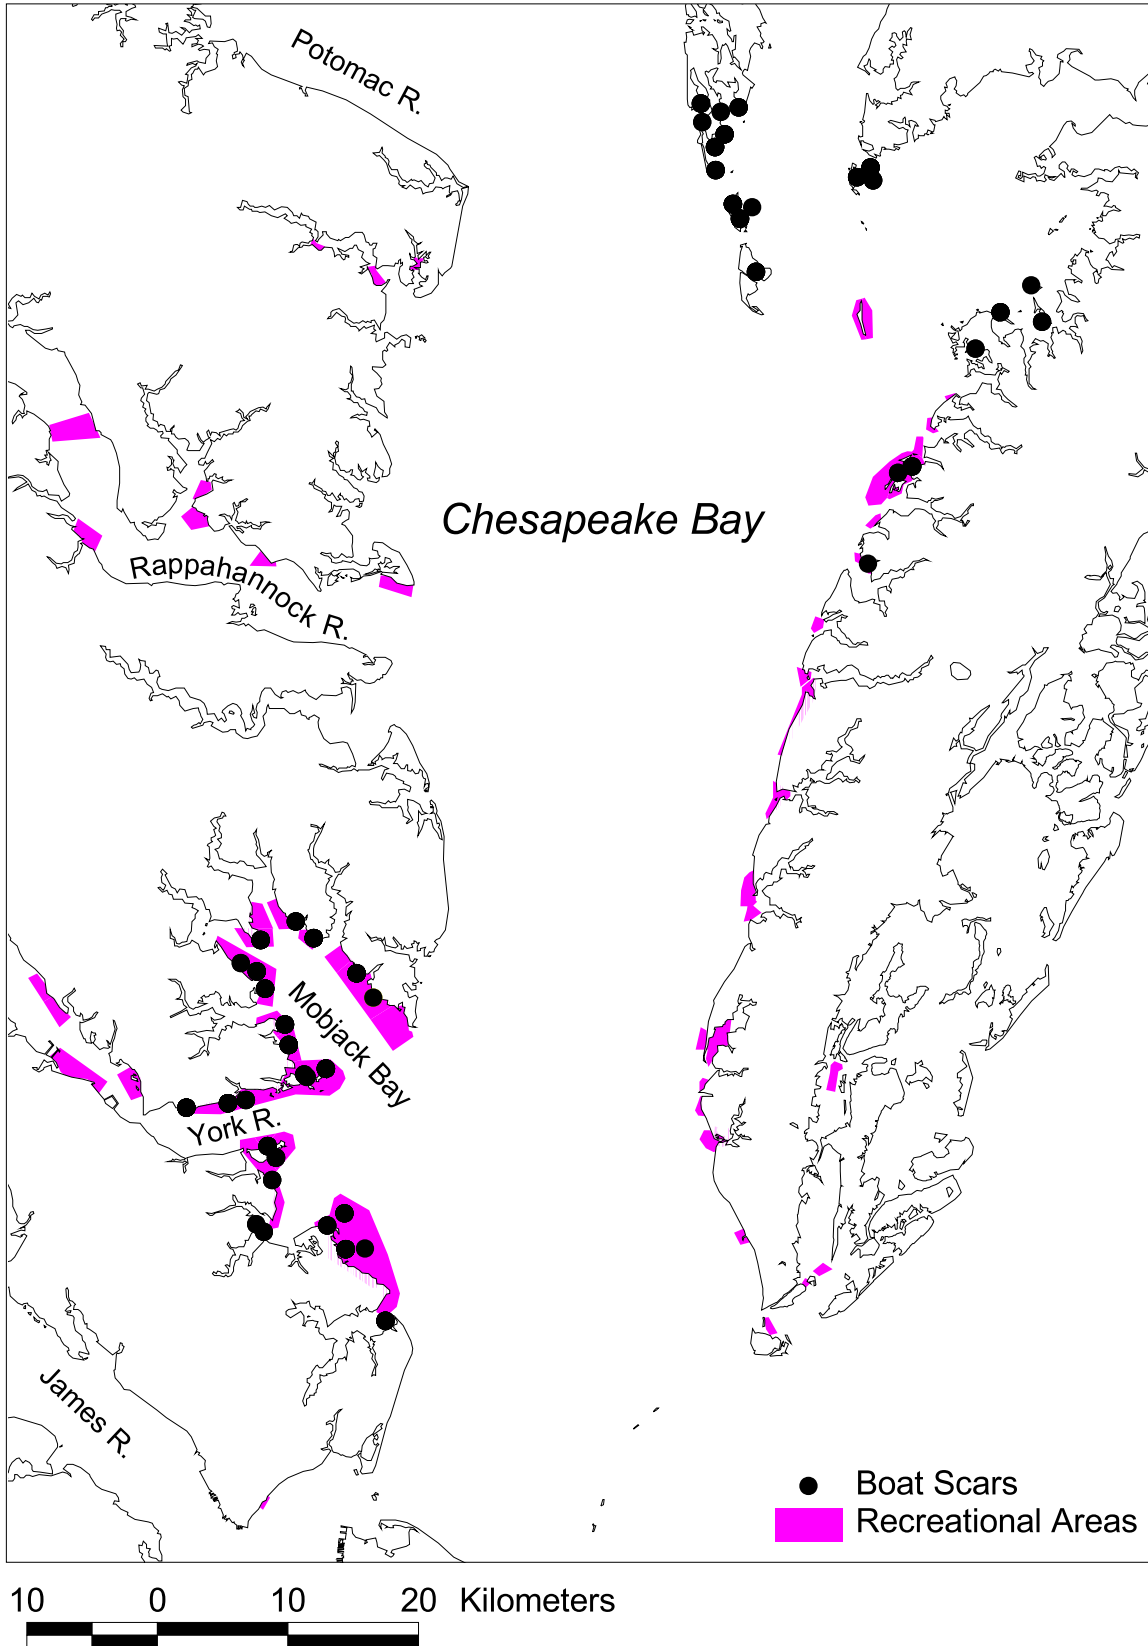
For example, on the eastern shore, a majority of the sites occurred within areas delineated by the VMRC survey as frequent crab scraping areas (**Table 1**). Scars within these sites were oriented in all directions (often randomly) and were often curved in shape. These scars are similar in orientation and curvature to sediment plumes visible in aerial photographs of active crab scraping (**Figures 21A and 22A**). Nonetheless, it is important to note that in some photographs showing active crab scraping, we often did not find scars in subsequent years' photography along the exact boat track (**Figures 21B and 22B**). However, scars are abundant within the regions in which scraping has been photographed or observed in the bottom use survey (**Figure 20**). This suggests that during scraping, scarring of the bottom is relatively rare, with any scars formed caused by propellers in shallower water and not by the scrape itself. If the actual scrape commonly created scars, it would be reasonable to assume that much more of the bottom would be scarred, resulting in higher intensity of scarring at more sites and in deeper waters, particularly given the high level of crab scraping occurring on the eastern shore. It remains unknown whether the crab scrape creates other, non-lethal damages to grassbeds such as reduced flowering or production, particularly in widgeon grass beds that are shallow and susceptible to being pulled out. Given that according to the survey a relatively low amount of recreational activity occurs in the area, and that haul seine activity on the eastern shore is primarily in areas outside the grassbeds, boats that are crab scraping are a likely cause of existing scarring in this region.

Figure 20) Map of the Bottom Use Survey from VMRC enforcement officials showing areas of A) frequent haul seining, B) crab scraping, and C) recreational use.

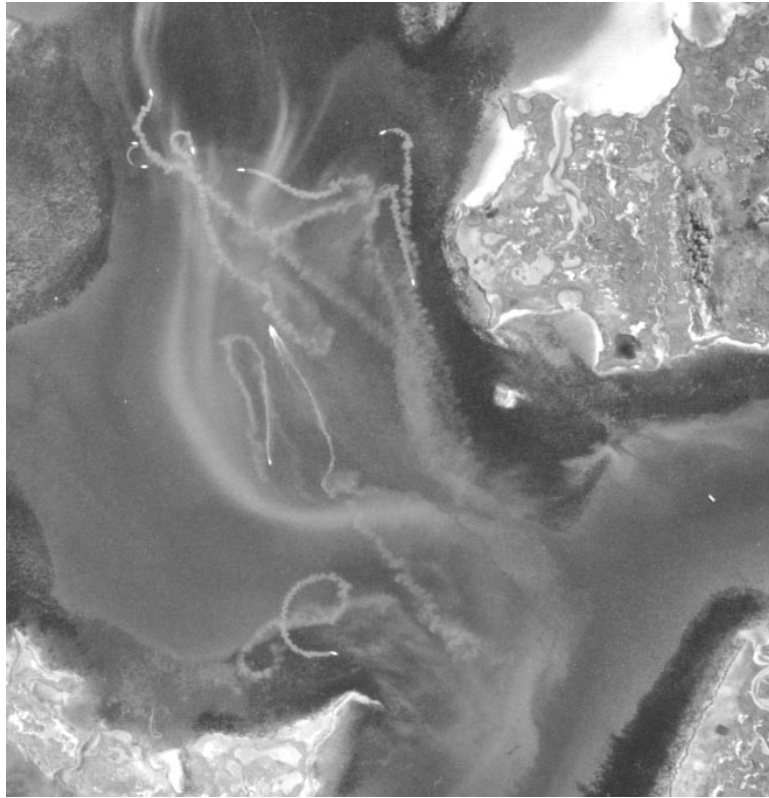
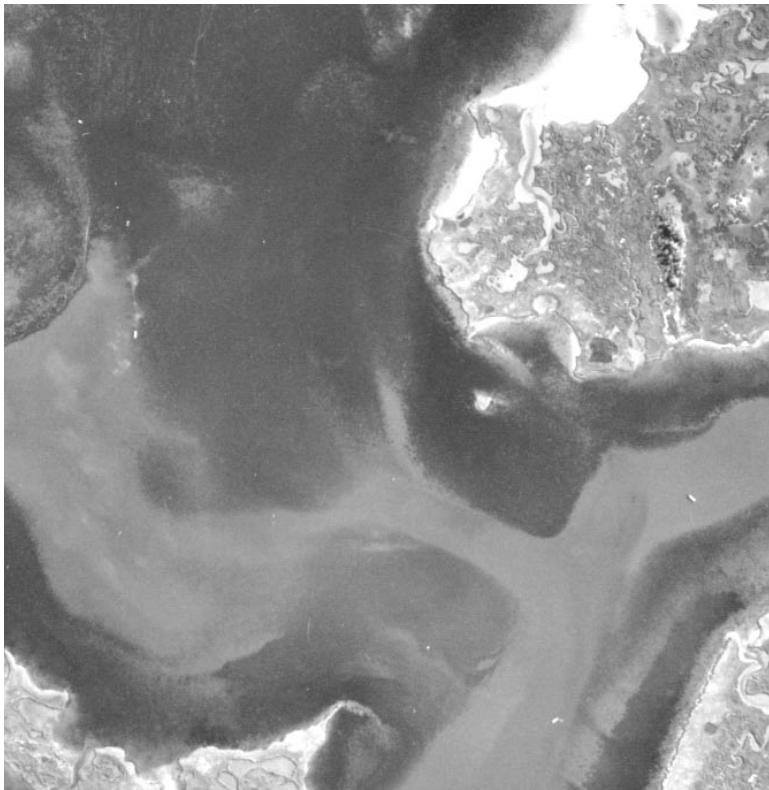
Figure 21) 1:24,000 scale aerial photograph of an area near Finney's Island on the eastern shore (North of Pungateague Creek), showing A) crab scraping occurring in a grass bed in 1996, with associated sediment plumes, and B) the same region in 1997 showing no scars along those boat tracks.

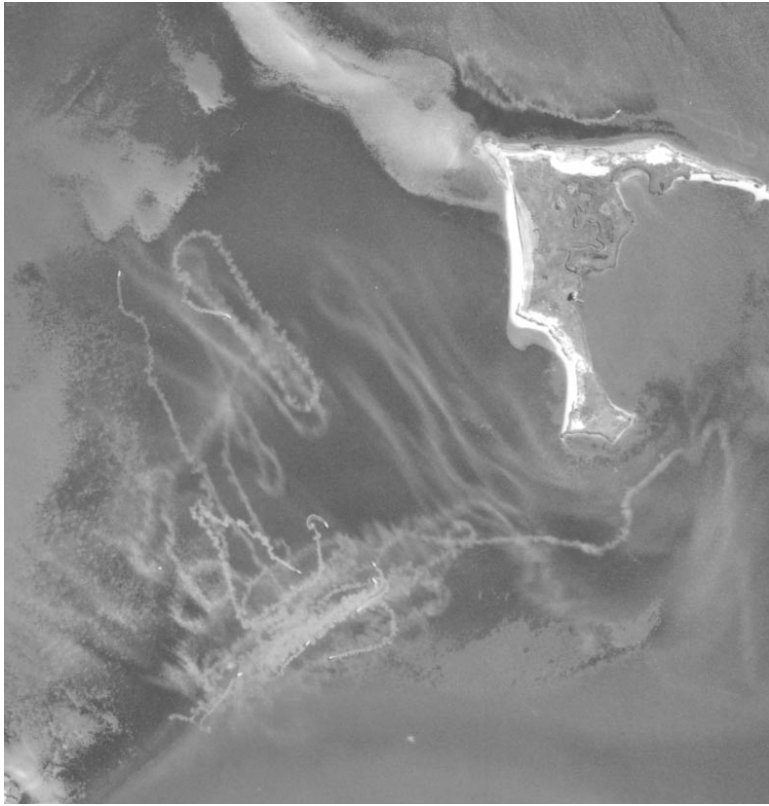
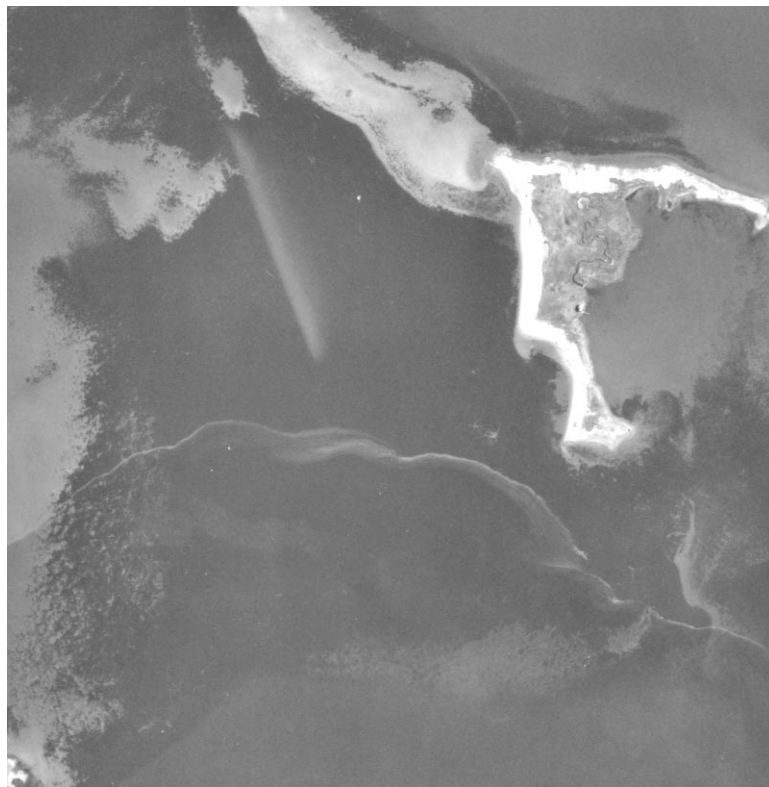
Figure 22) 1:24,000 scale aerial photograph of an area near Webb Island on the eastern shore showing A) crab scraping occurring in a grass bed in 1997, with associated

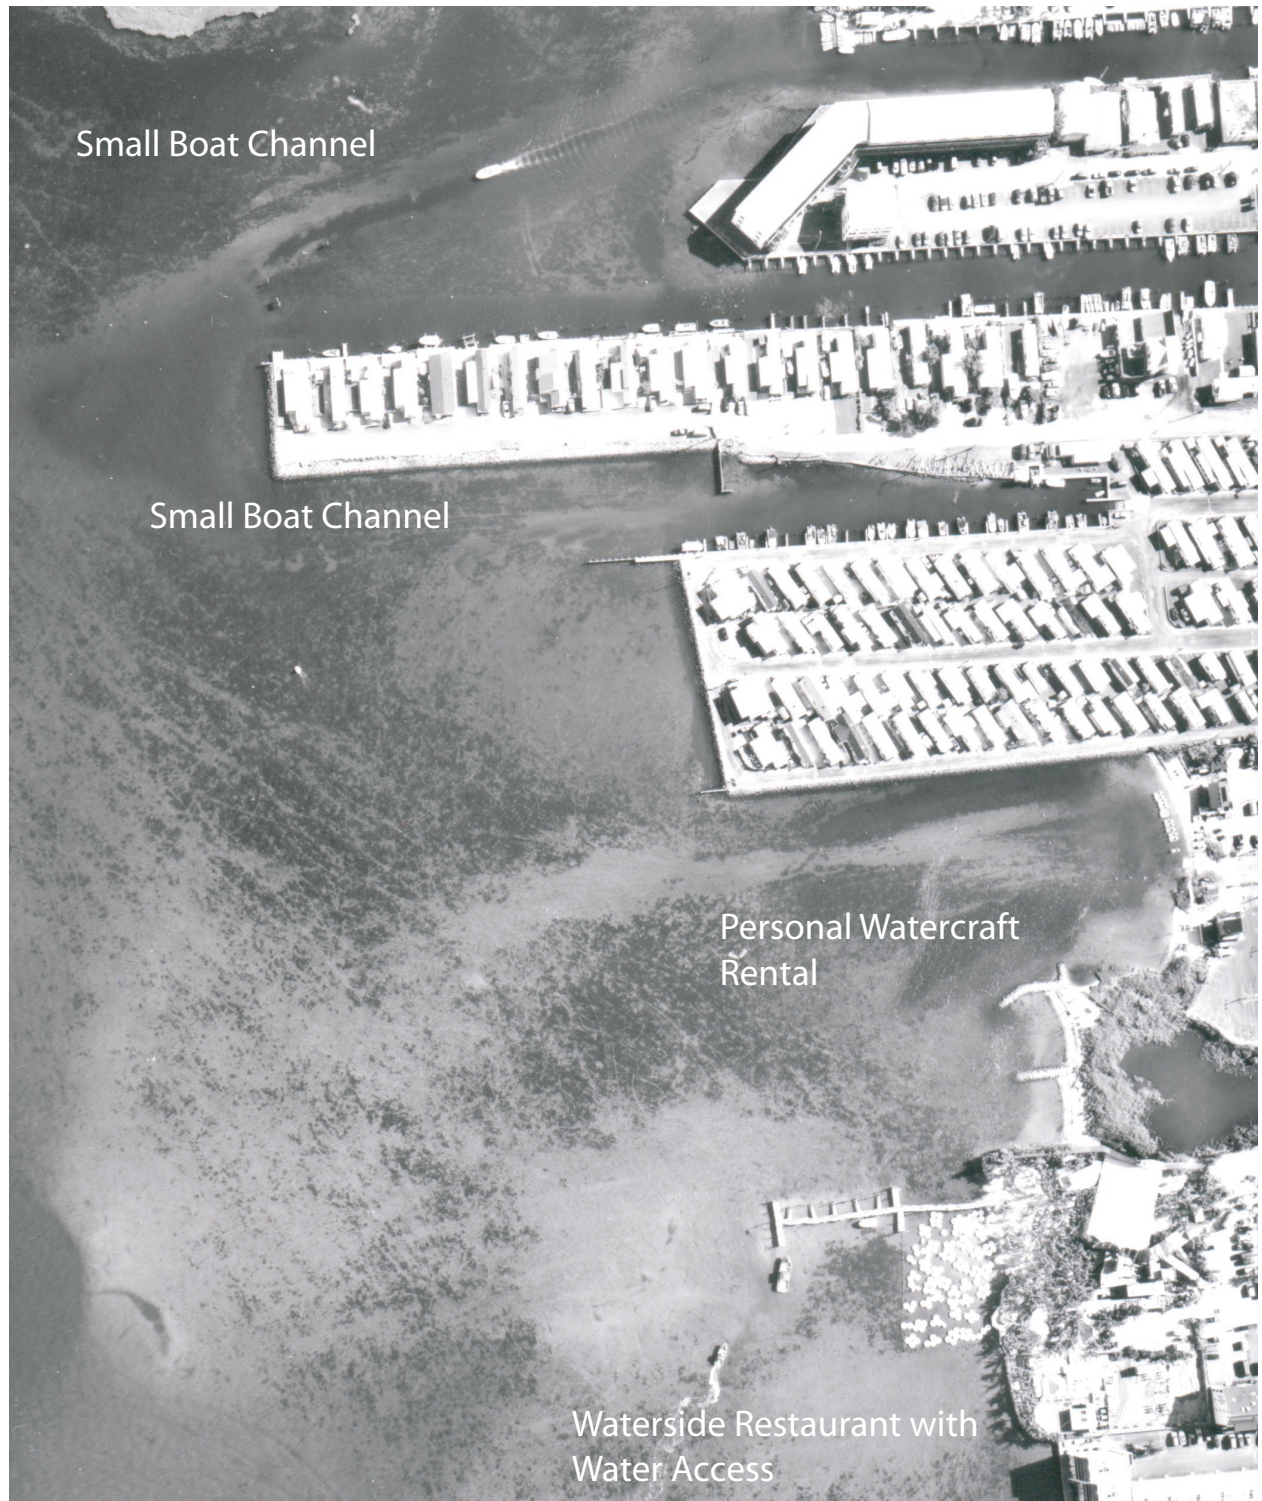
Figure 24: Boat Scarring in Ocean City, Maryland

Figure 24) 1:2000 scale aerial photograph in Sinepuxent Bay, Ocean City, Maryland. Scars near small boat channels are visible, as are scars from a personal watercraft rental vendor. On the bottom of the photograph is a restaurant frequented by small boats which power through the grass bed as well as anchor within the bed. At each place, the area is nearly devoid of vegetation. (photograph courtesy Maryland Department of Natural Resources).
